GREATER DUBLIN DRAINAGE PROJECT

EIAR Addendum Chapter 11A (Biodiversity (Terrestrial and Freshwater Aquatic))
Appendix A11.1 Terrestrial Baseline Survey Report

IE000258
S4P01
October 2023

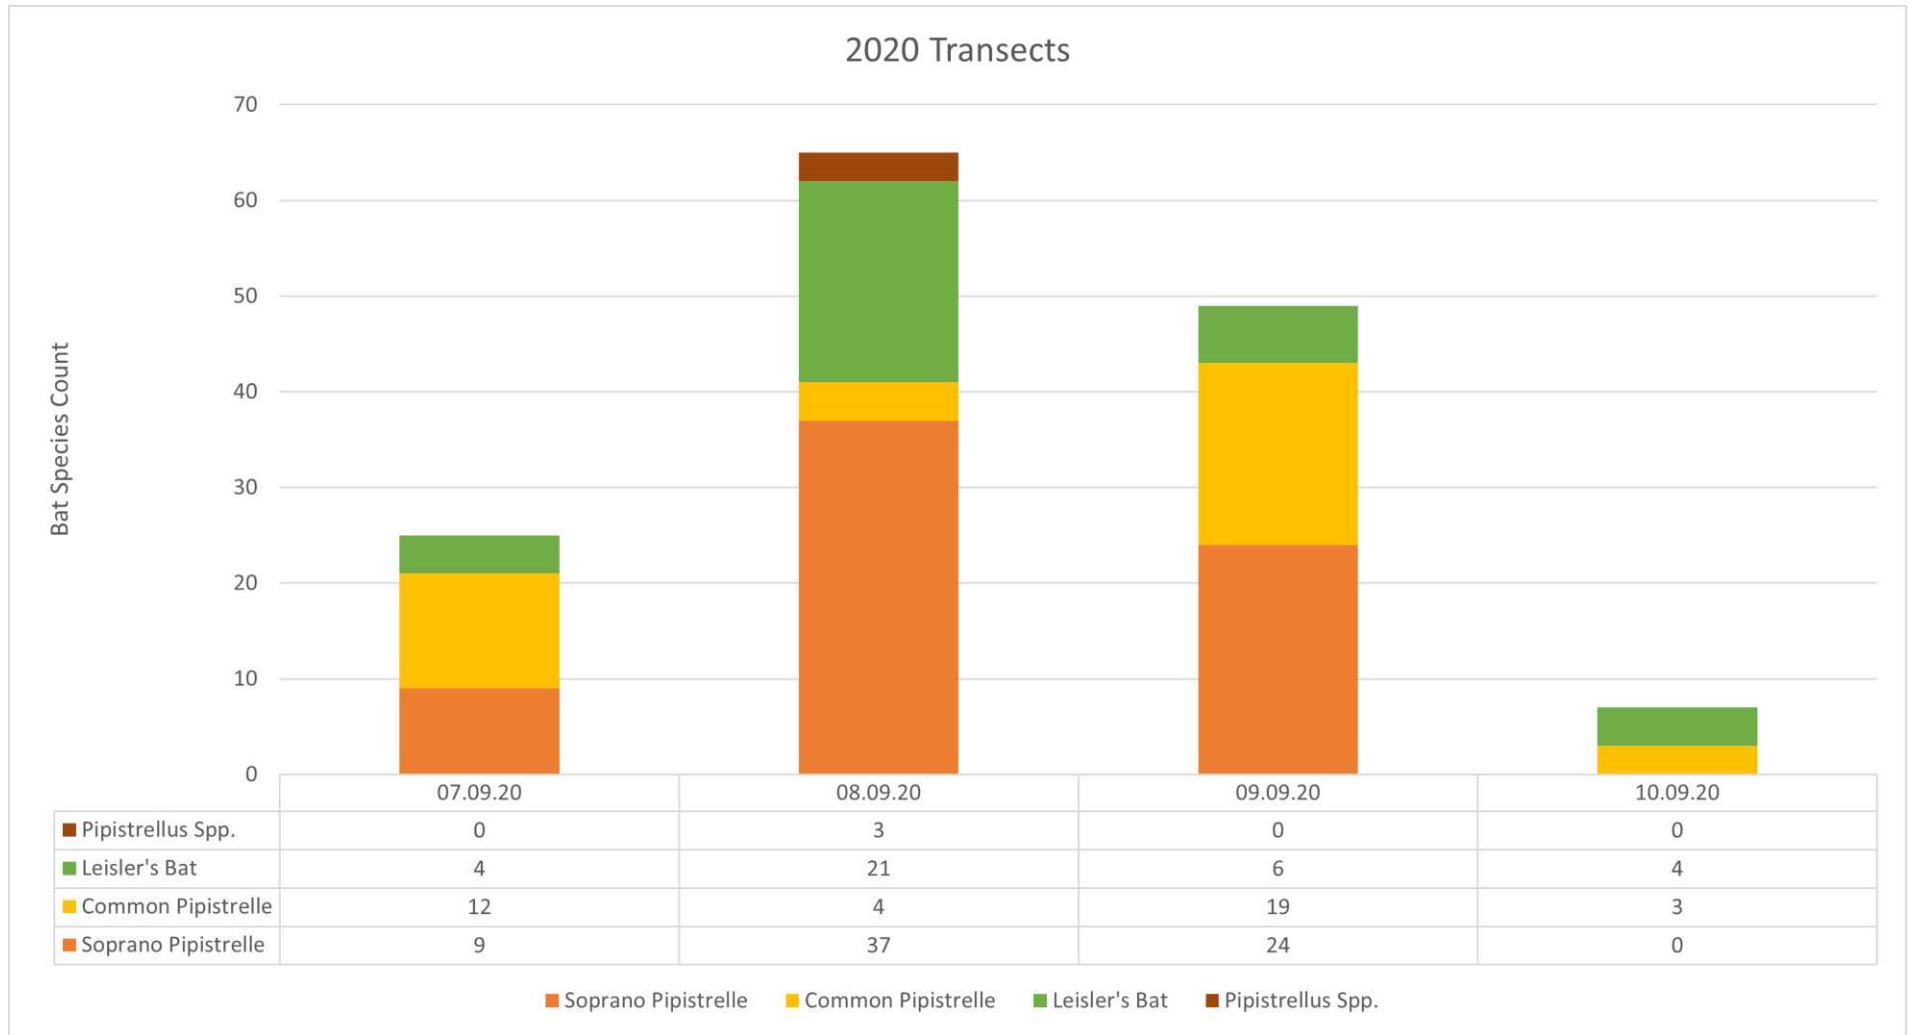
Figure 3-6: Bat counts by species on 2020 transects

Soprano pipistrelle (*Pipistrellus pygmaeus*) was the most common species occurrence during the 2020 transects, with Leisler’s bat (*Nyctalus leisleri*), and common pipistrelle (*Pipistrellus pipistrellus*) frequently occurring across the four days (see **Figure 3-6**). A species count of 65 was recorded on 8 September, 49 on 9 September, 25 on 7 of September, and 7 on 10 of September.

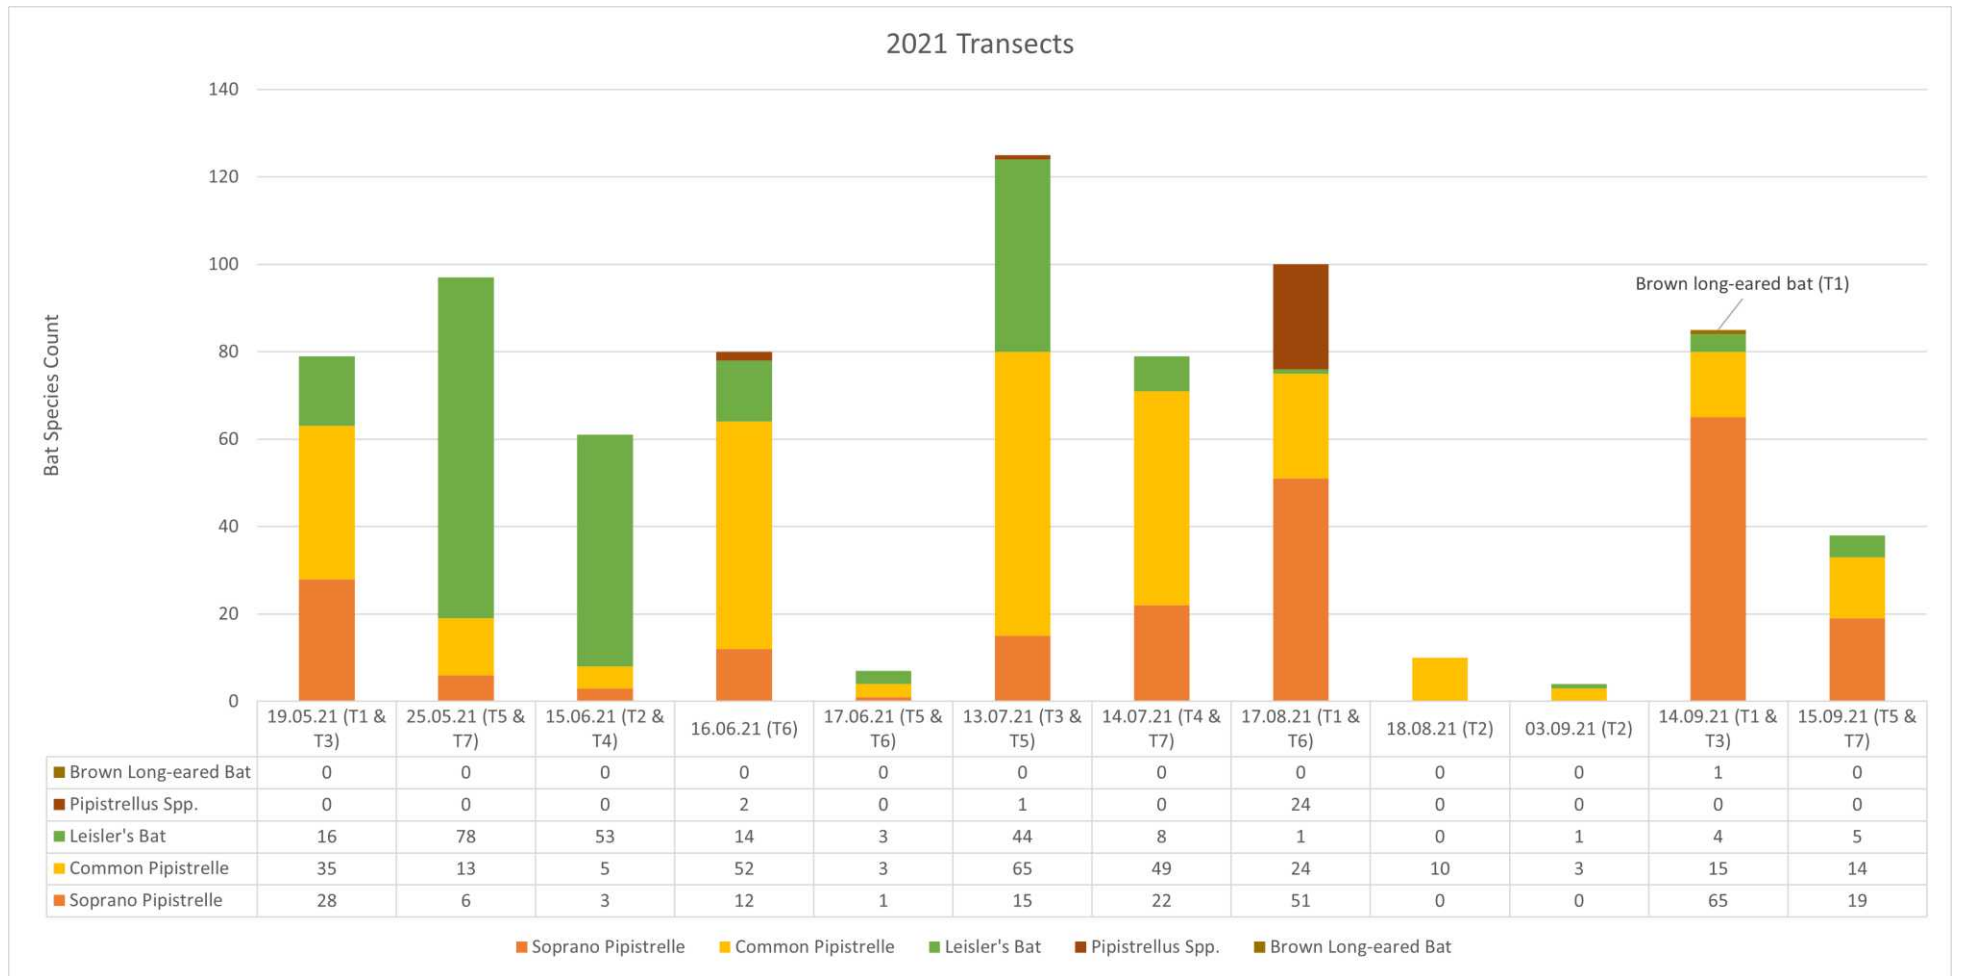
Figure 3-7: Bat counts by species on transects during 2021

In 2021, aside from data collected on 17 June, 18 August, and 3 September which had low counts (<10), species counts ranged between 38 and 125 per transect (see **Figure 3-7**). As transect 2 data was only collected on 18 August and 3 September, the total species count for transect 2 was 14, of which 13 were common pipistrelle. The species compositions varied across the transects, with common pipistrelle, Leisler’s bat, and soprano pipistrelle the most common. There was one recording of a brown long-eared bat (*Plecotus auritus*) on 14 September at transect 1 (see **Figure 3-7**). In total, 70% of the species recorded were in the *Pipistrellus* family.

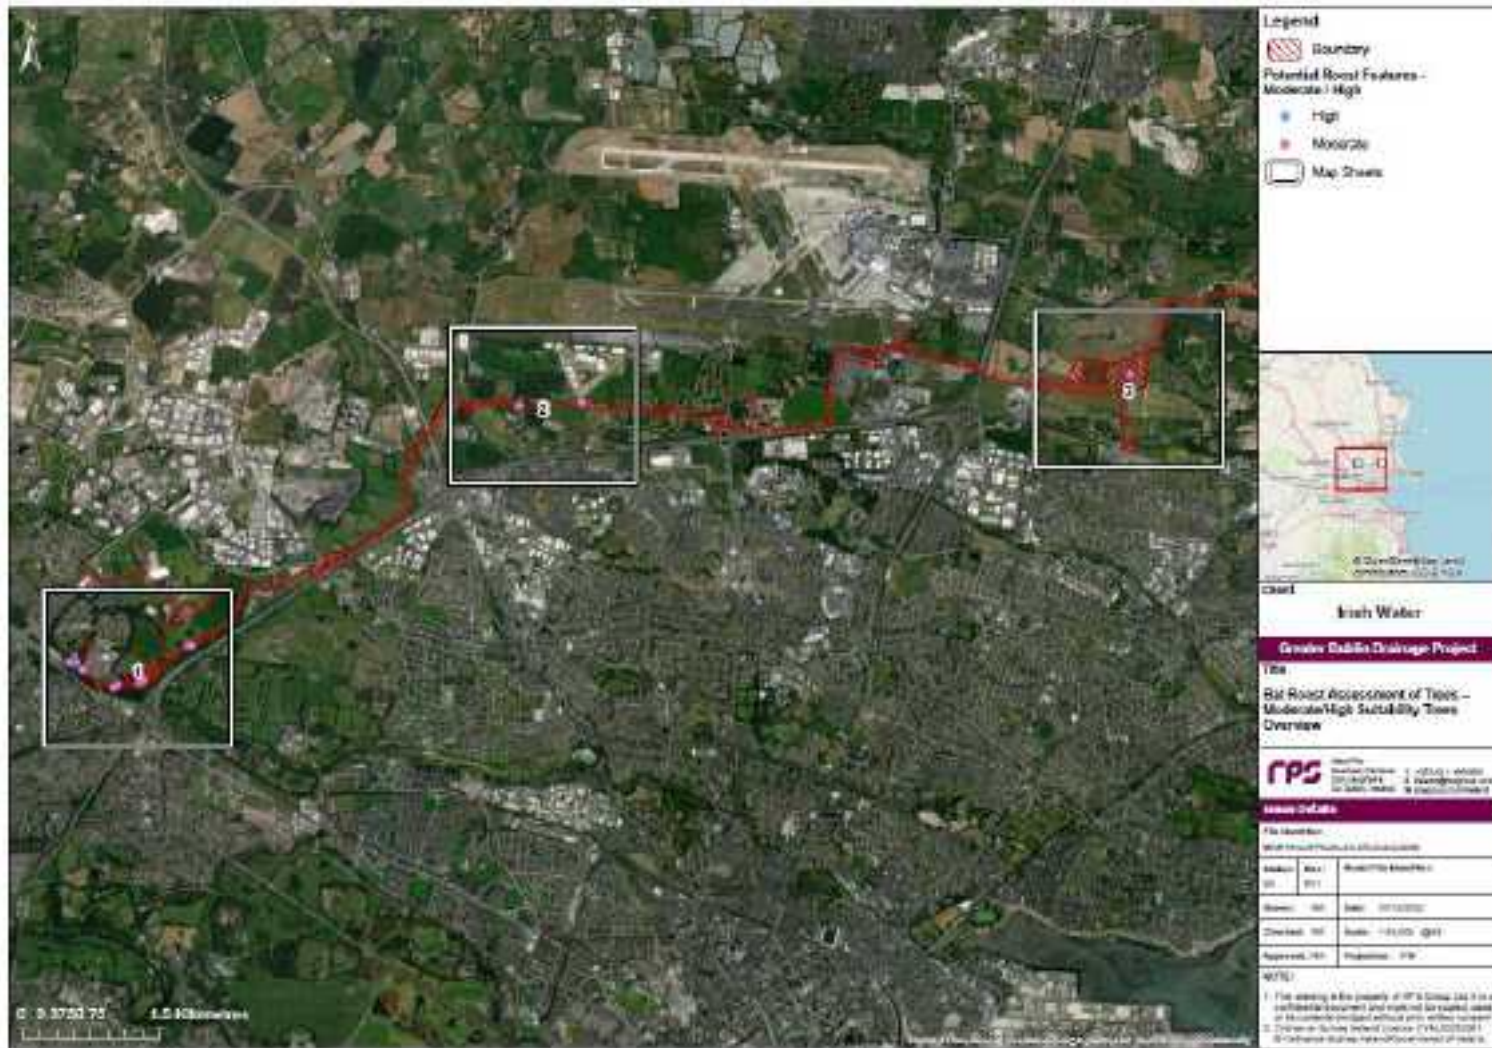
Figure 3-9: Tree locations of moderate/high bat roost potential (Sheet 1)

A total of eight trees were considered to support Moderate bat roosting suitability, and these include Trees 1-2, 1-7, 1-9, 1-20, 1-22, 2-1, and 2-3 (**Table 3-6**). A tree with Moderate bat roosting suitability is a “tree with one or more potential roost sites that could be used by bats due to their size, shelter, protection, conditions and surrounding habitat but unlikely to support a roost of high conservation status..” (Collins J. 2016). These trees do not hold cavities which could support a larger roost such as a maternity colony.

Trees 1-35 and 1-52 were considered to support High bat roosting suitability (**Table 3-6**). According to Bat surveys for professional ecologists: Good practice guidelines (3rd edn) (Collins J. 2016), a tree with High Bat Roosting Suitability is a “*tree with one or more potential roost sites that are obviously suitable for use by a larger number of bats on a more regular basis and potentially for longer periods of time due to their size, shelter, protection, conditions and surrounding habitat*”. These trees hold cavities which could potentially support a larger roost such as a maternity colony. Forensic evidence of bats such as droppings or urine stains do not always persist long in trees. However, there was no evidence at all recorded in any of the trees surveyed, potentially indicating that if they are bat roosts, they have not been occupied recently.

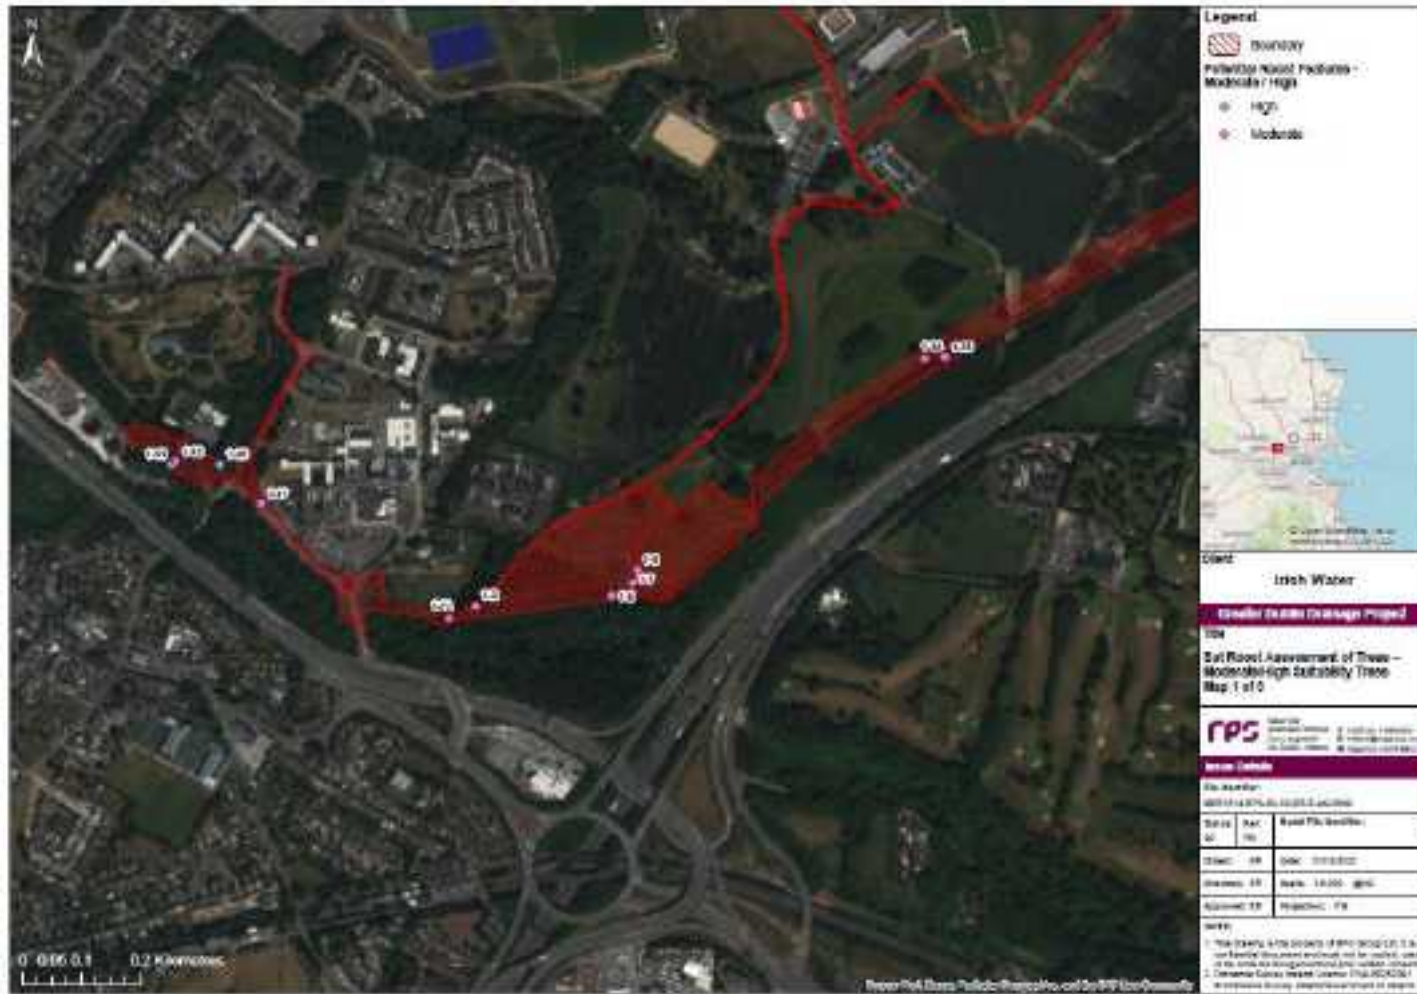
Figure 3-9: Tree locations of moderate/high bat roost potential (Sheet 2)

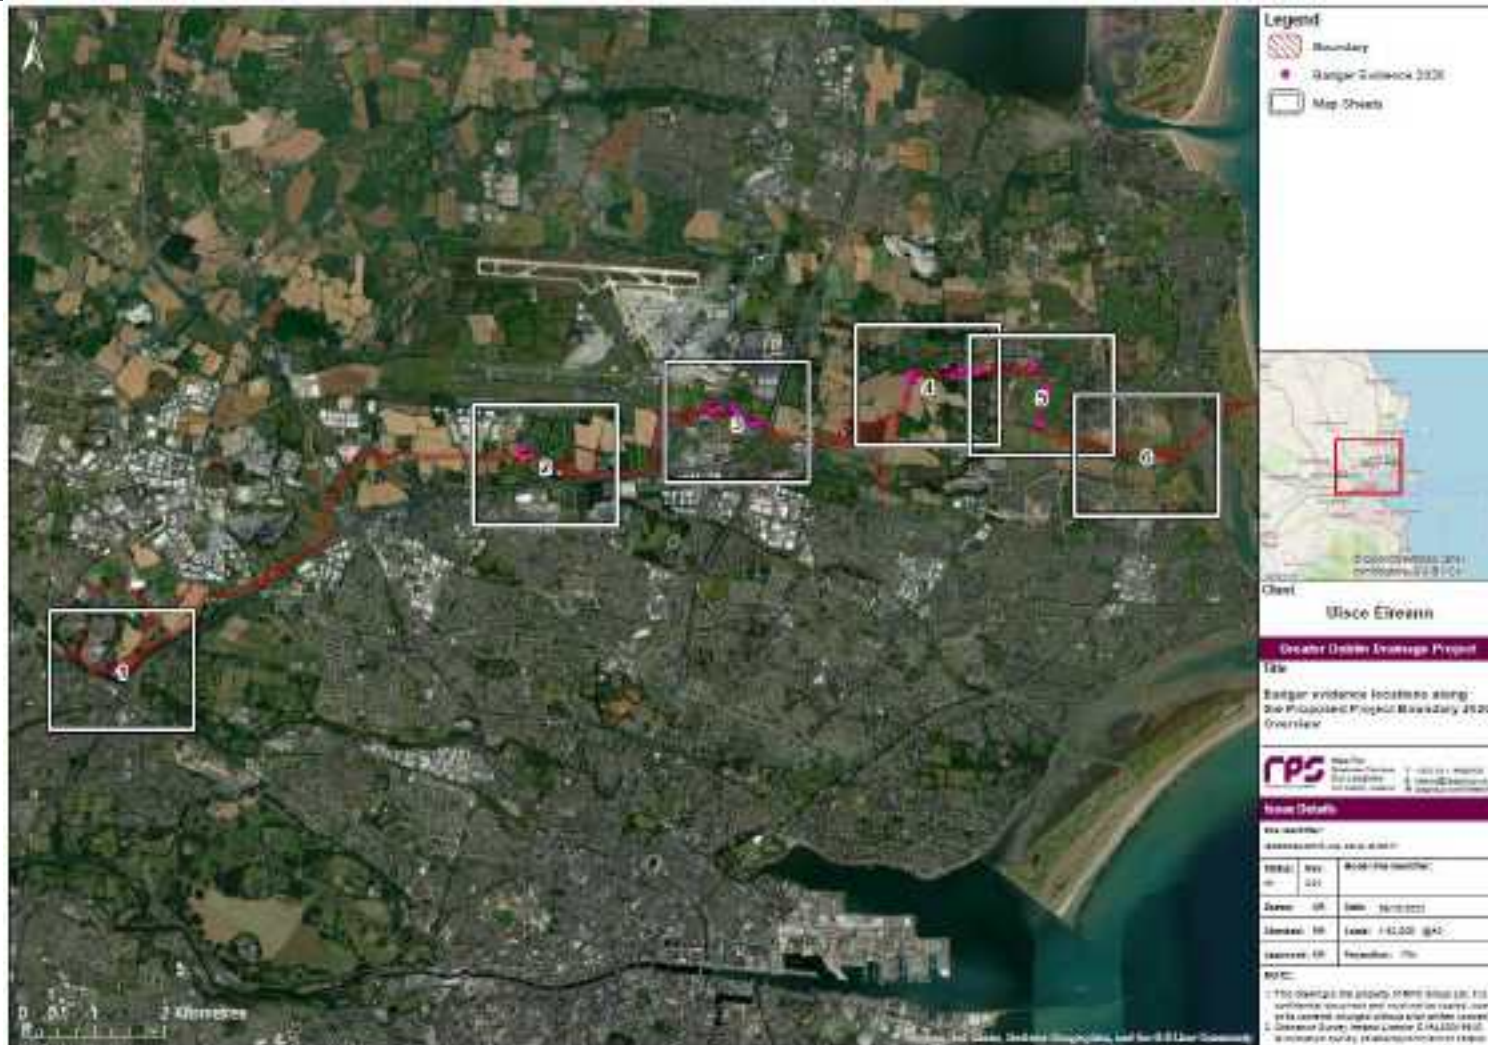
Figure B-1 Badger evidence locations along the Proposed Project Boundary 2020 (Overview)

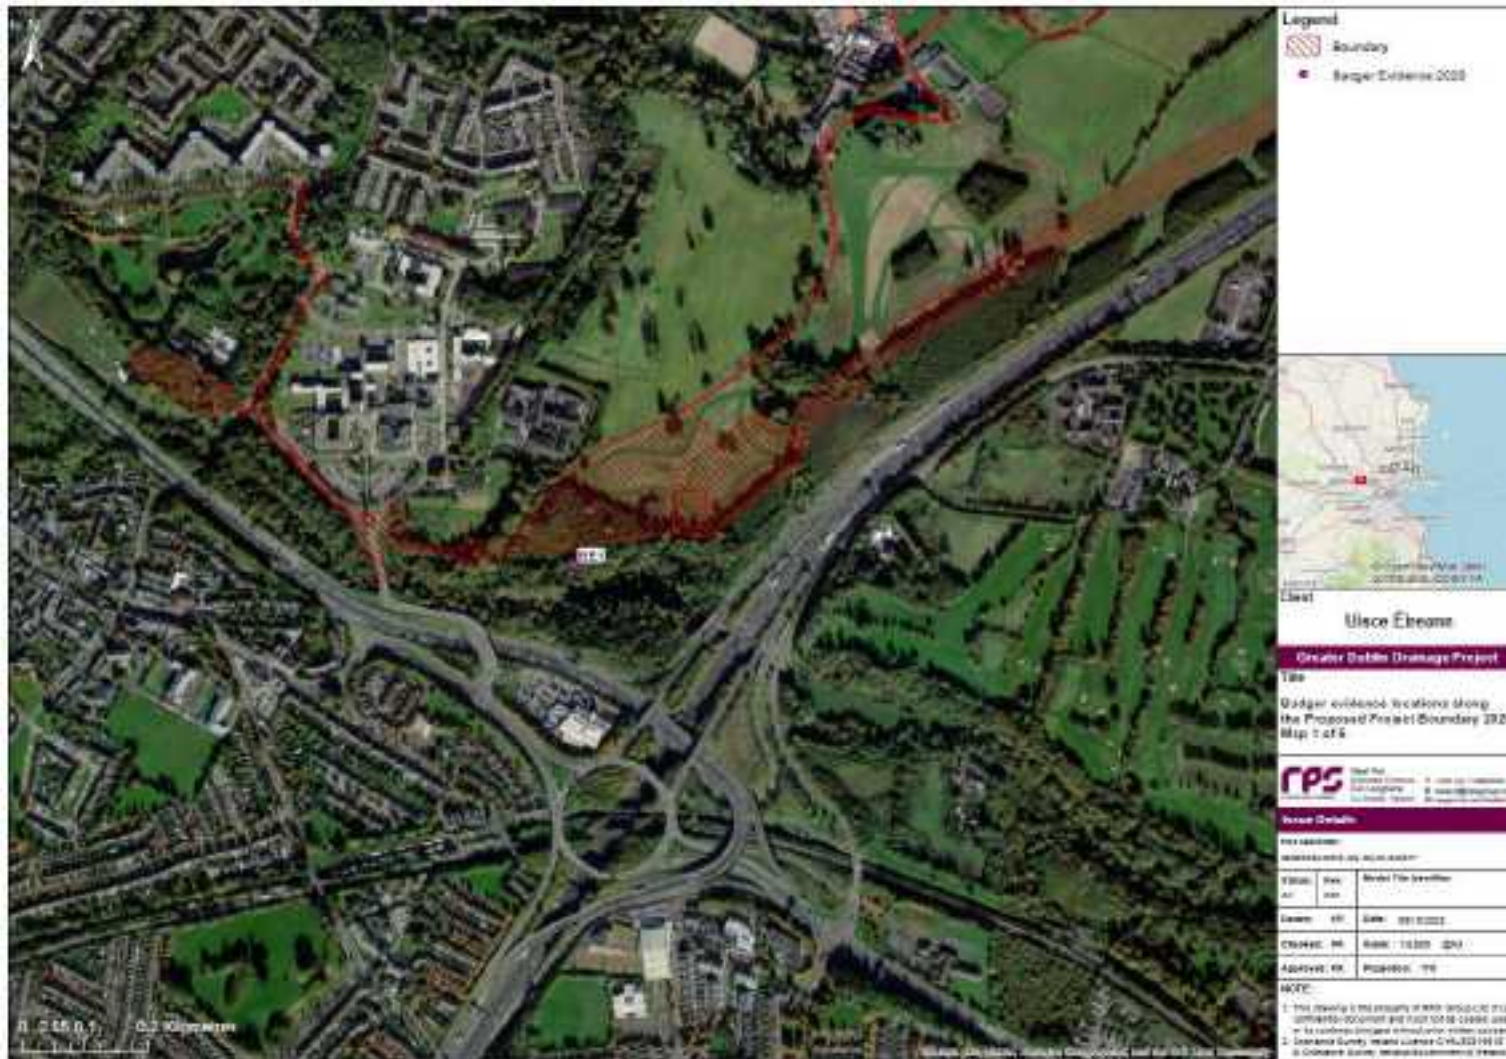
Figure B-2 Badger evidence locations along the Proposed Project Boundary 2020 (1)

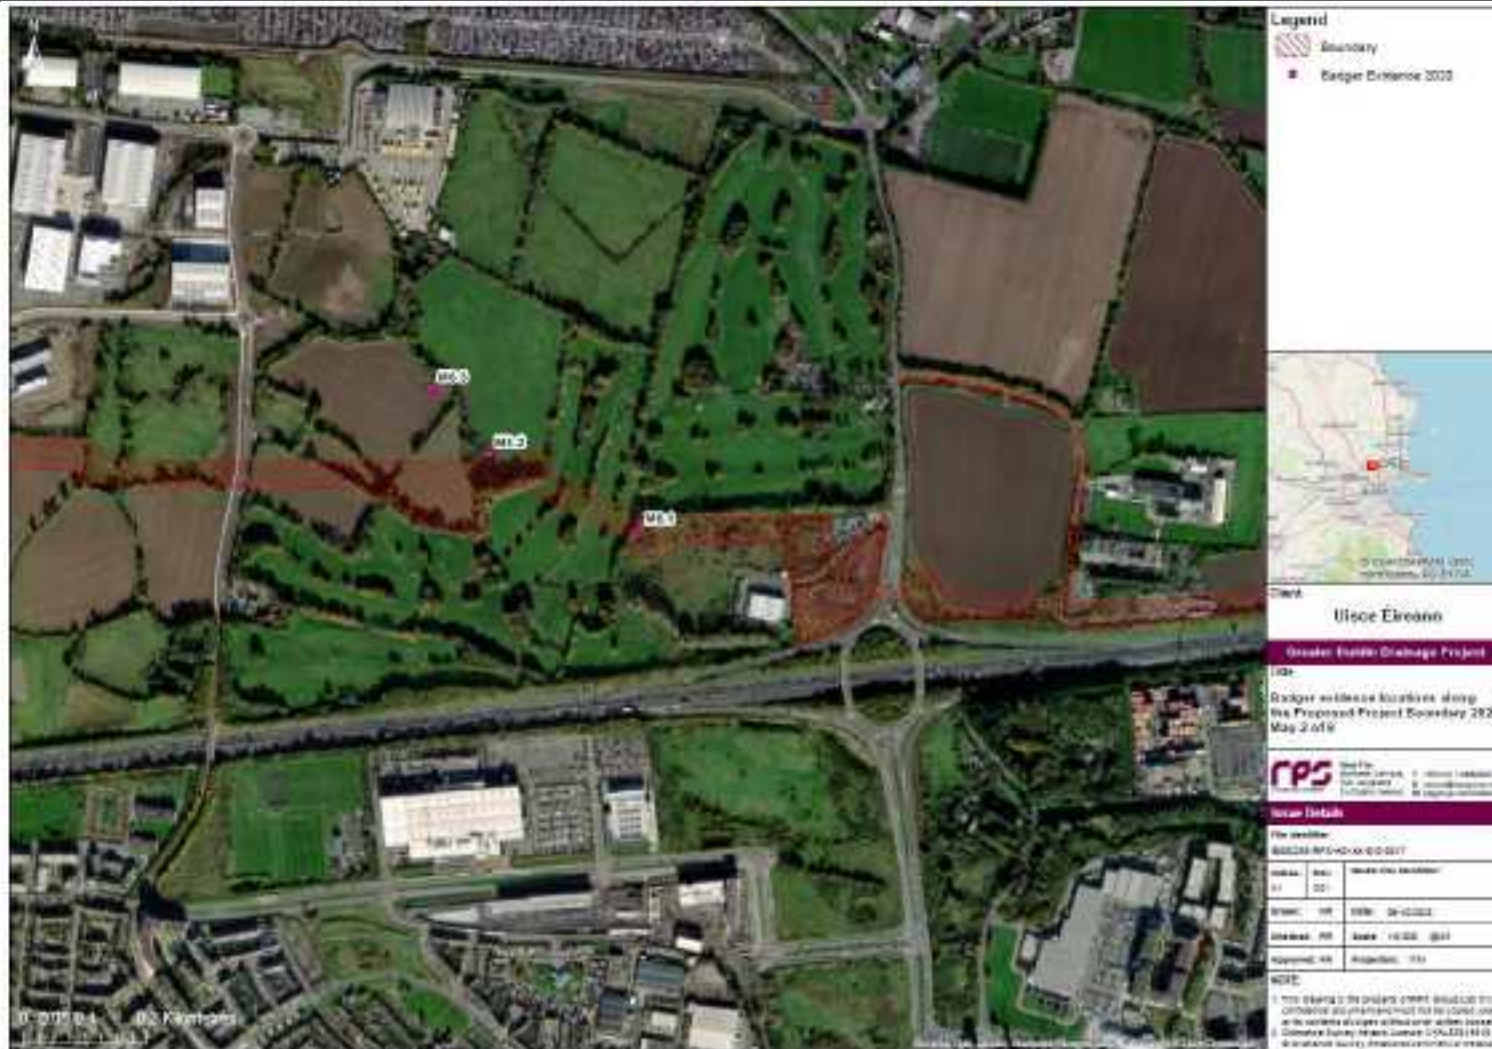
Figure B-3 Badger evidence locations along the Proposed Project Boundary 2020 (2)

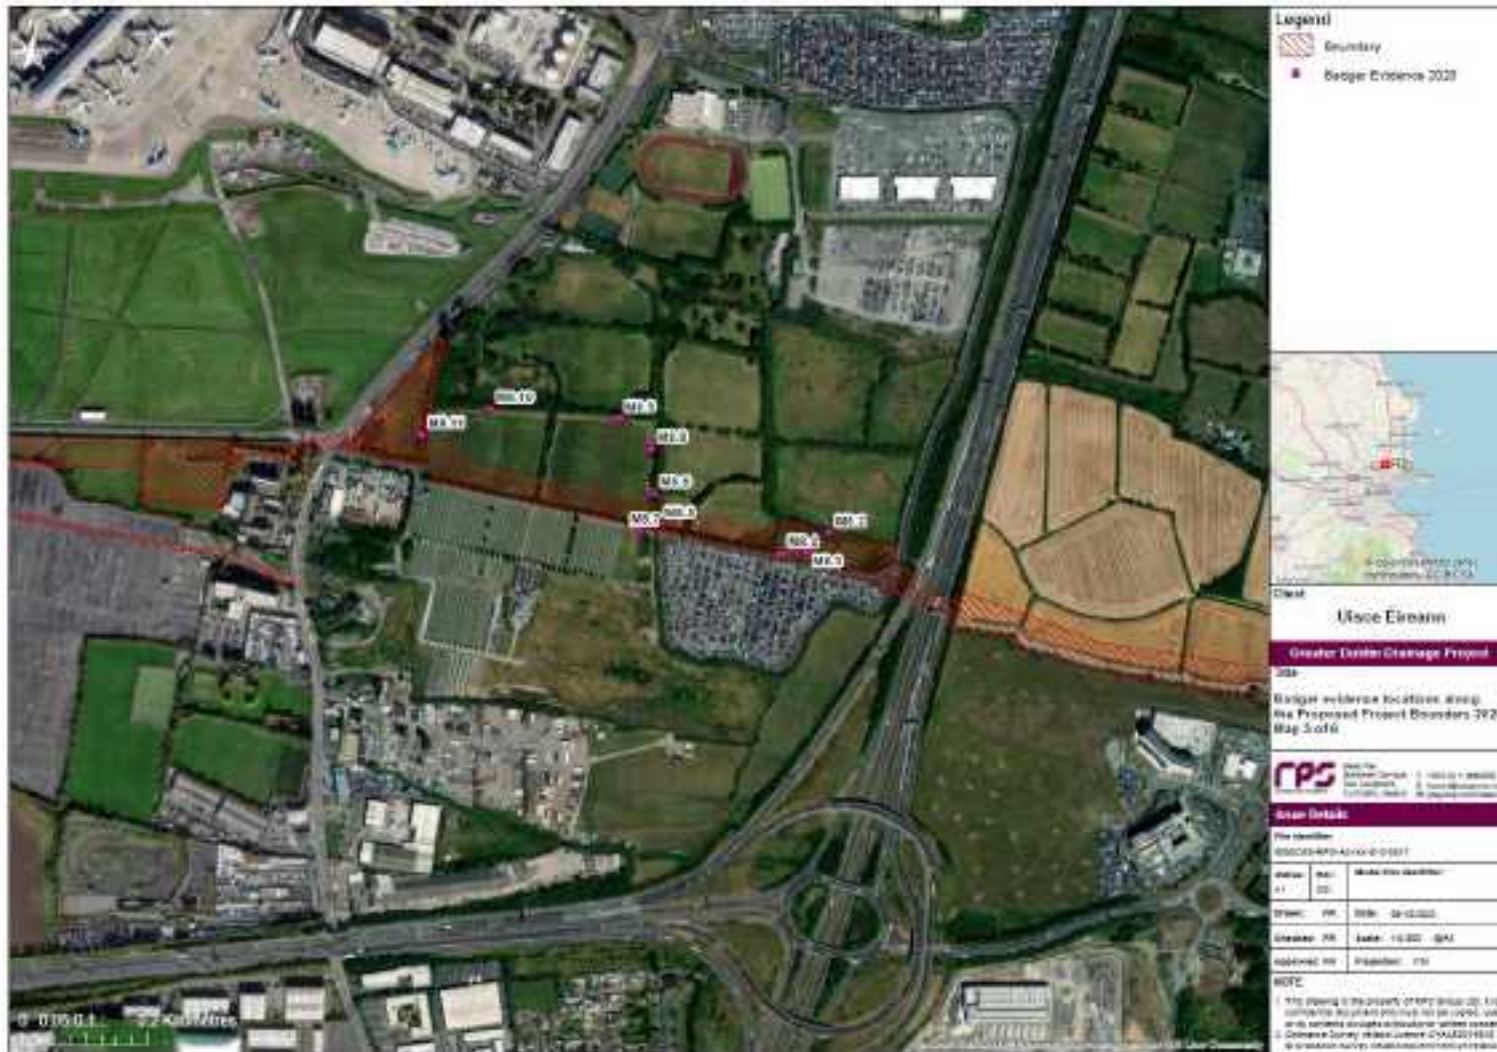
Figure B-4 Badger evidence locations along the Proposed Project Boundary 2020 (3)

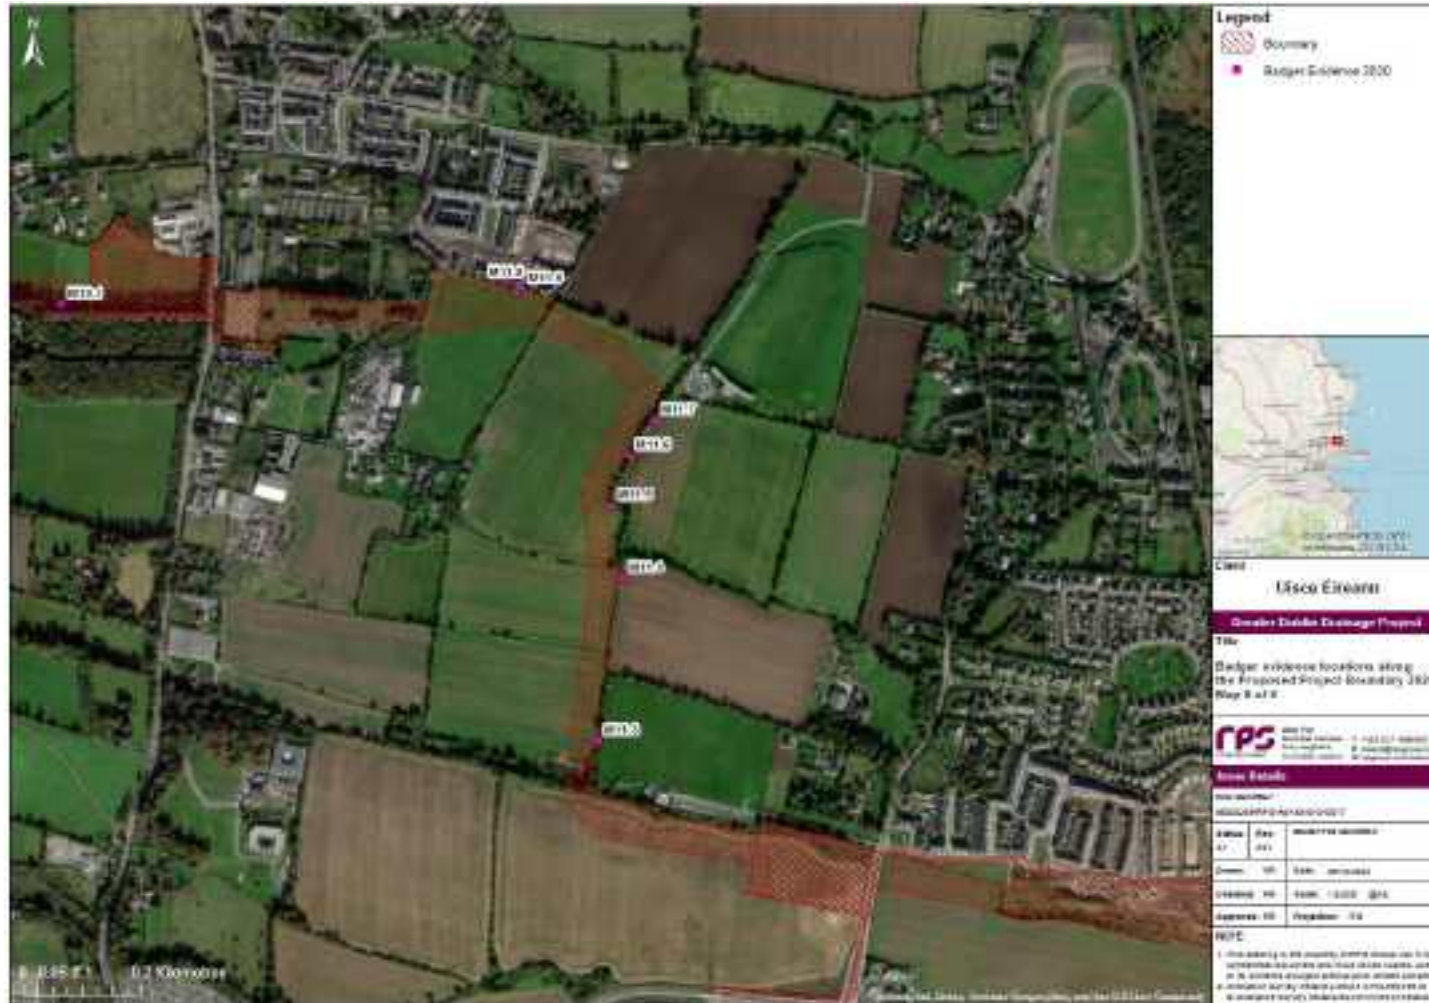
Figure B-6 Badger evidence locations along the Proposed Project Boundary 2020 (5)

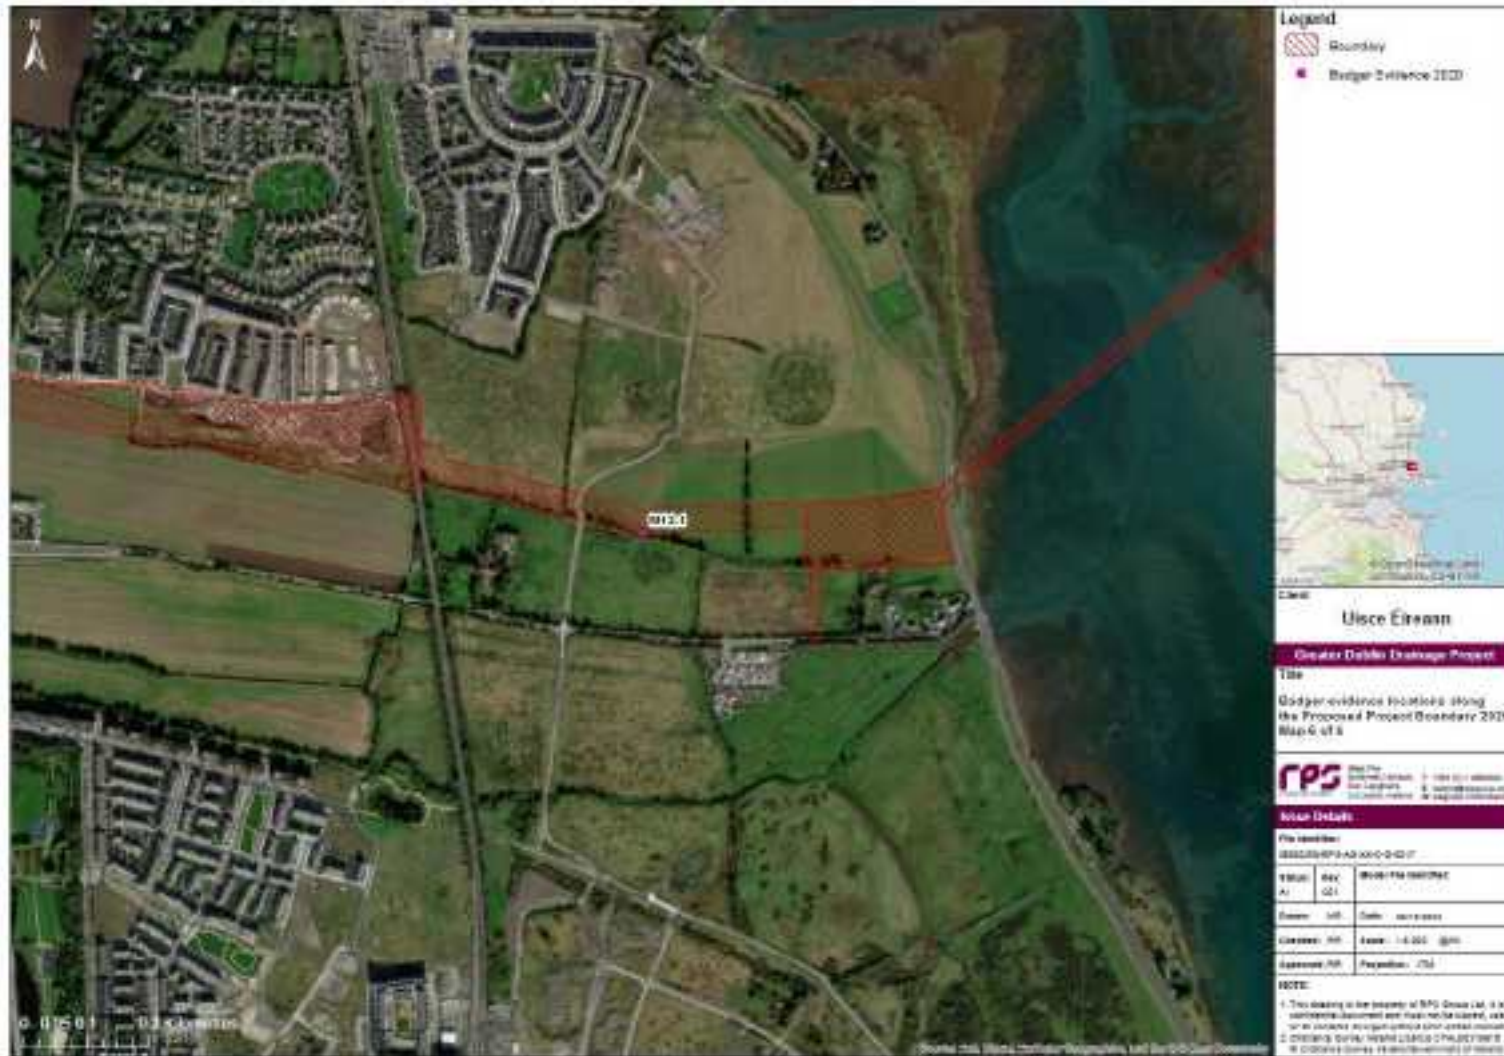
Figure B-7 Badger evidence locations along the Proposed Project Boundary 2020 (6)

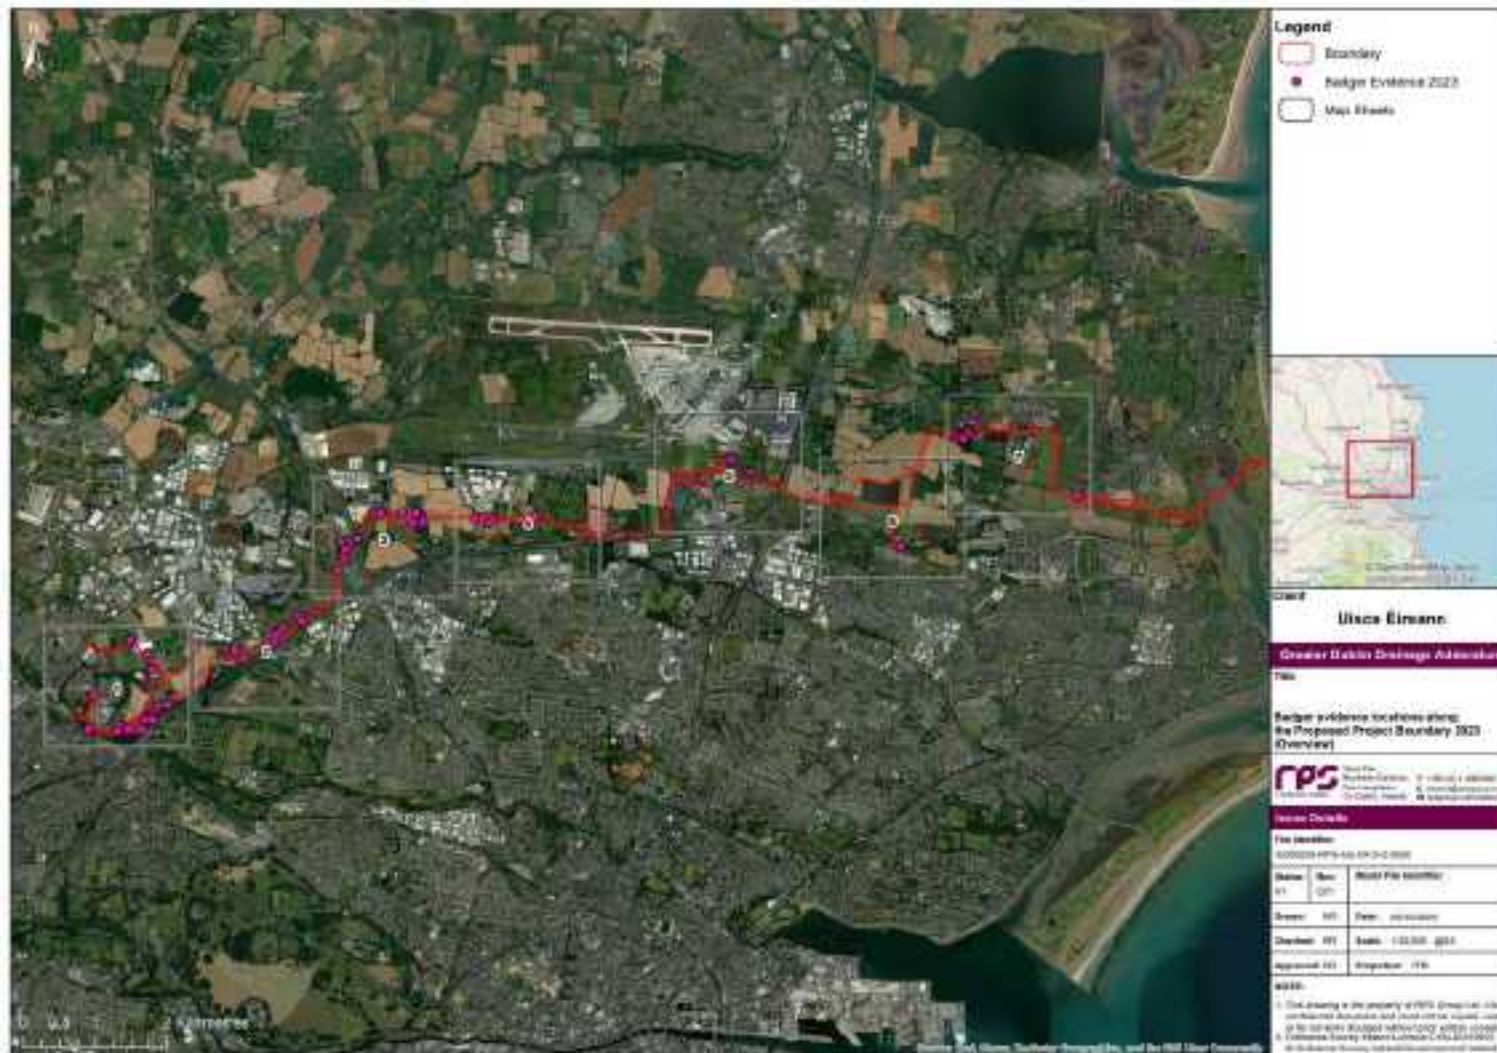
Figure C-1 Badger evidence locations along the Proposed Project Boundary 2023 (Overview)

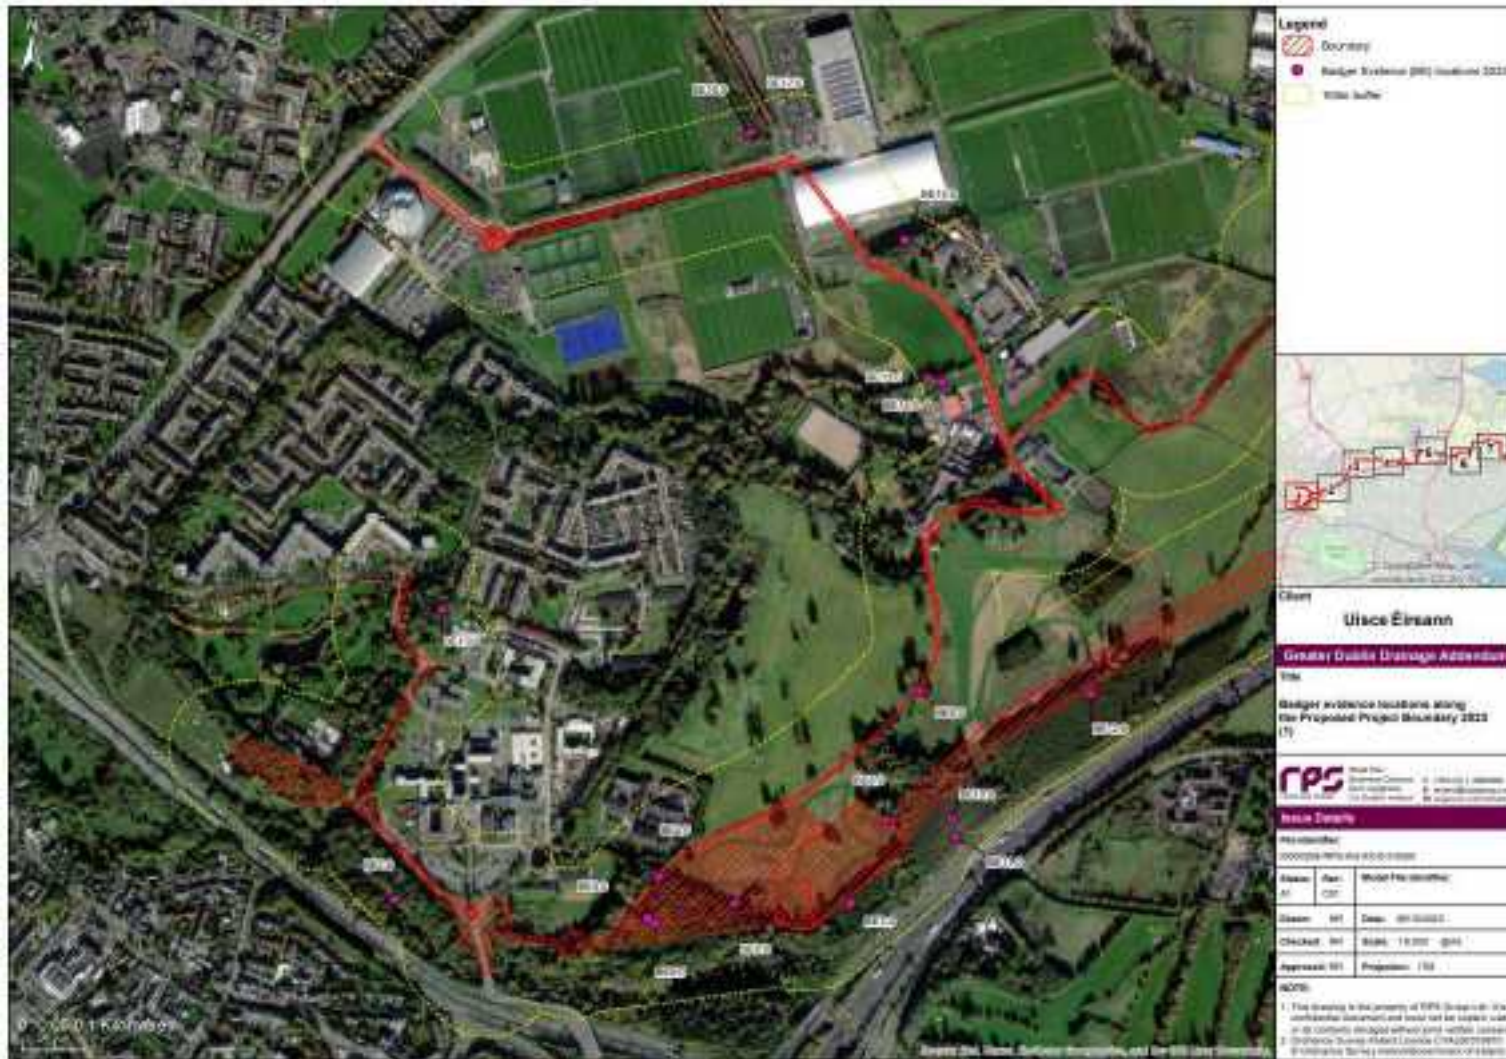
Figure C-2 Badger evidence locations along the Proposed Project Boundary 2023 (1)

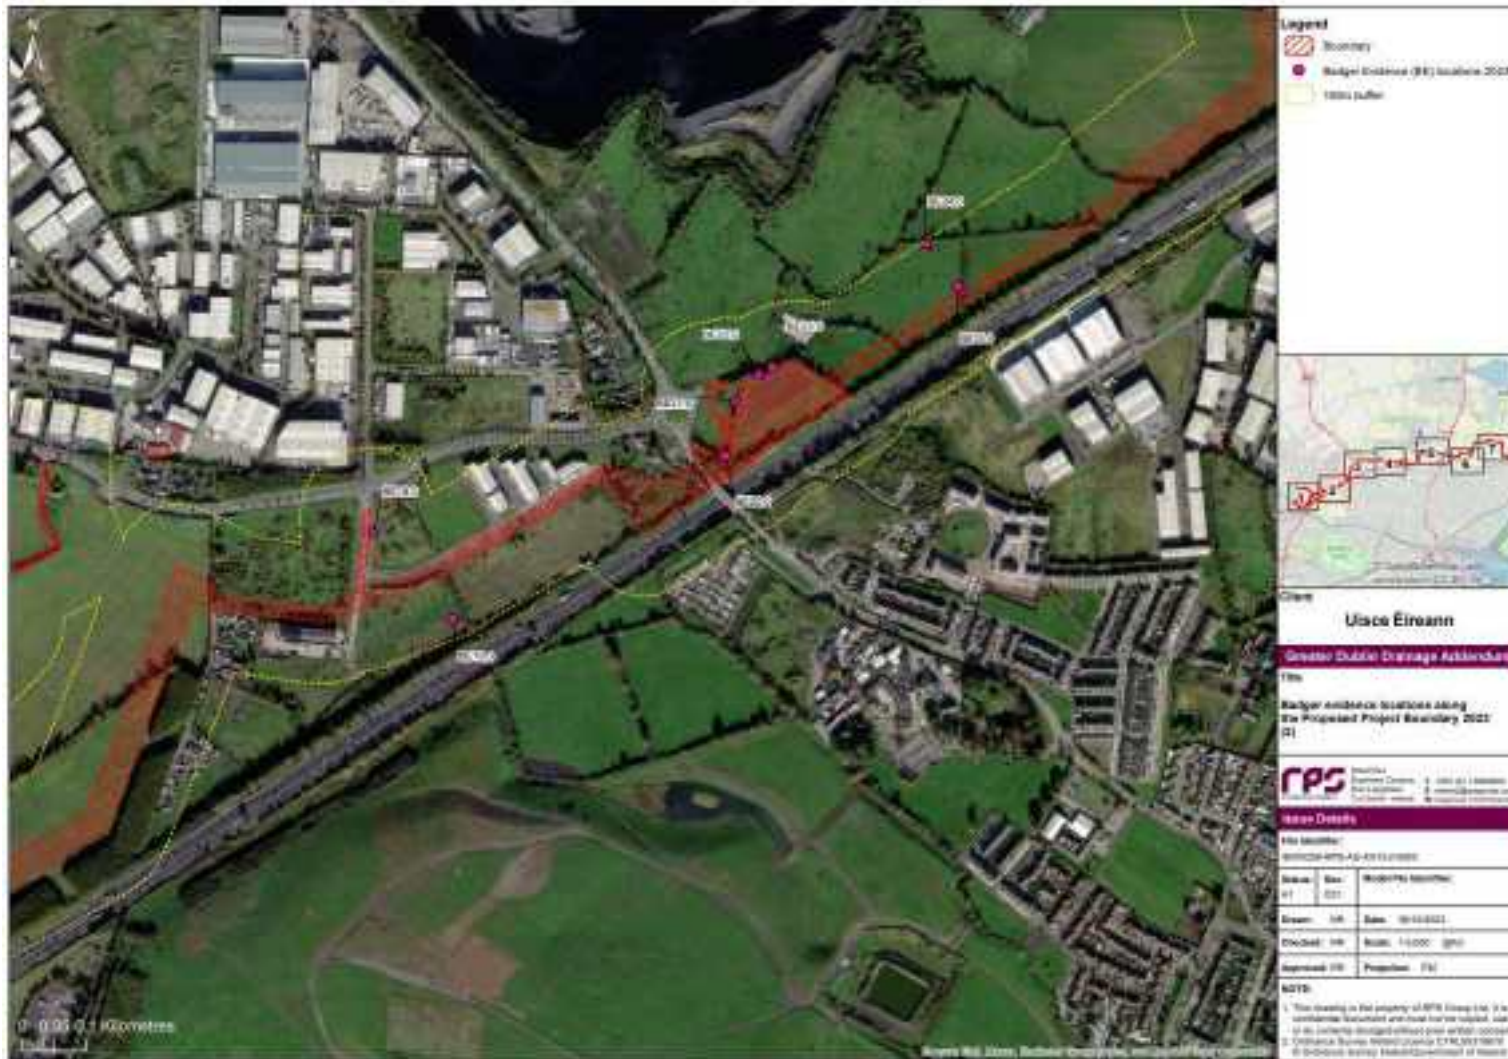
Figure C-3 Badger evidence locations along the Proposed Project Boundary 2023 (2)
