GREATER DUBLIN DRAINAGE PROJECT

EIAR Addendum Chapter 11A (Biodiversity (Terrestrial and Freshwater Aquatic))
Appendix A11.1 Terrestrial Baseline Survey Report

IE000258
S4P01
October 2023

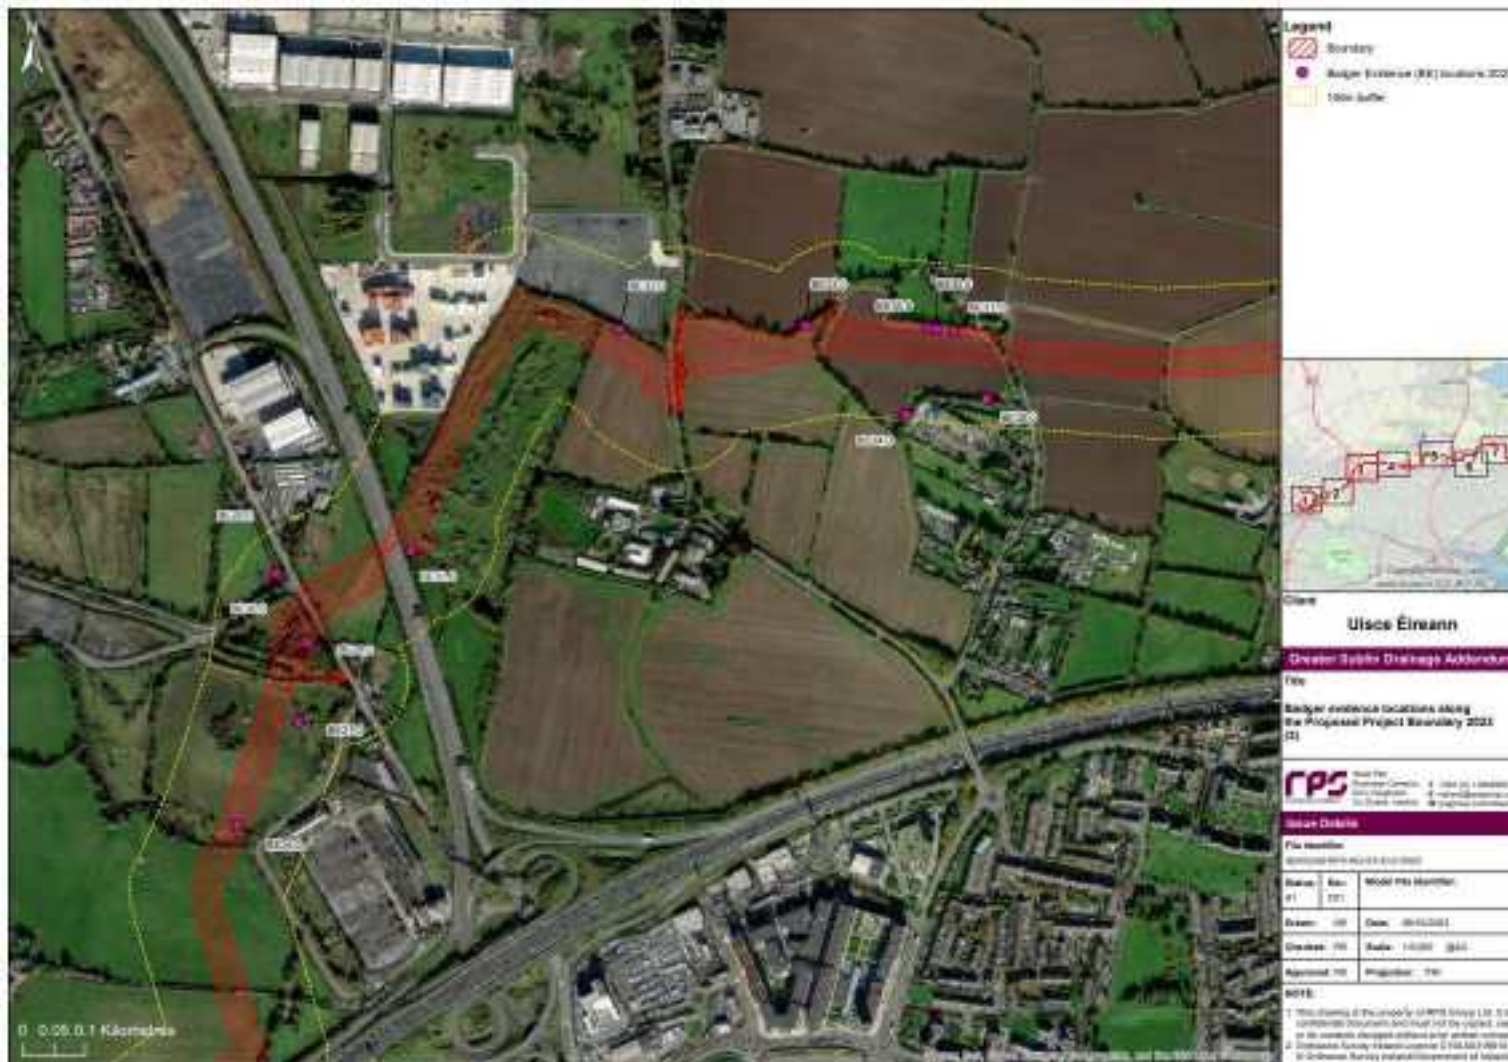
Figure C-4 Badger evidence locations along the Proposed Project Boundary 2023 (3)

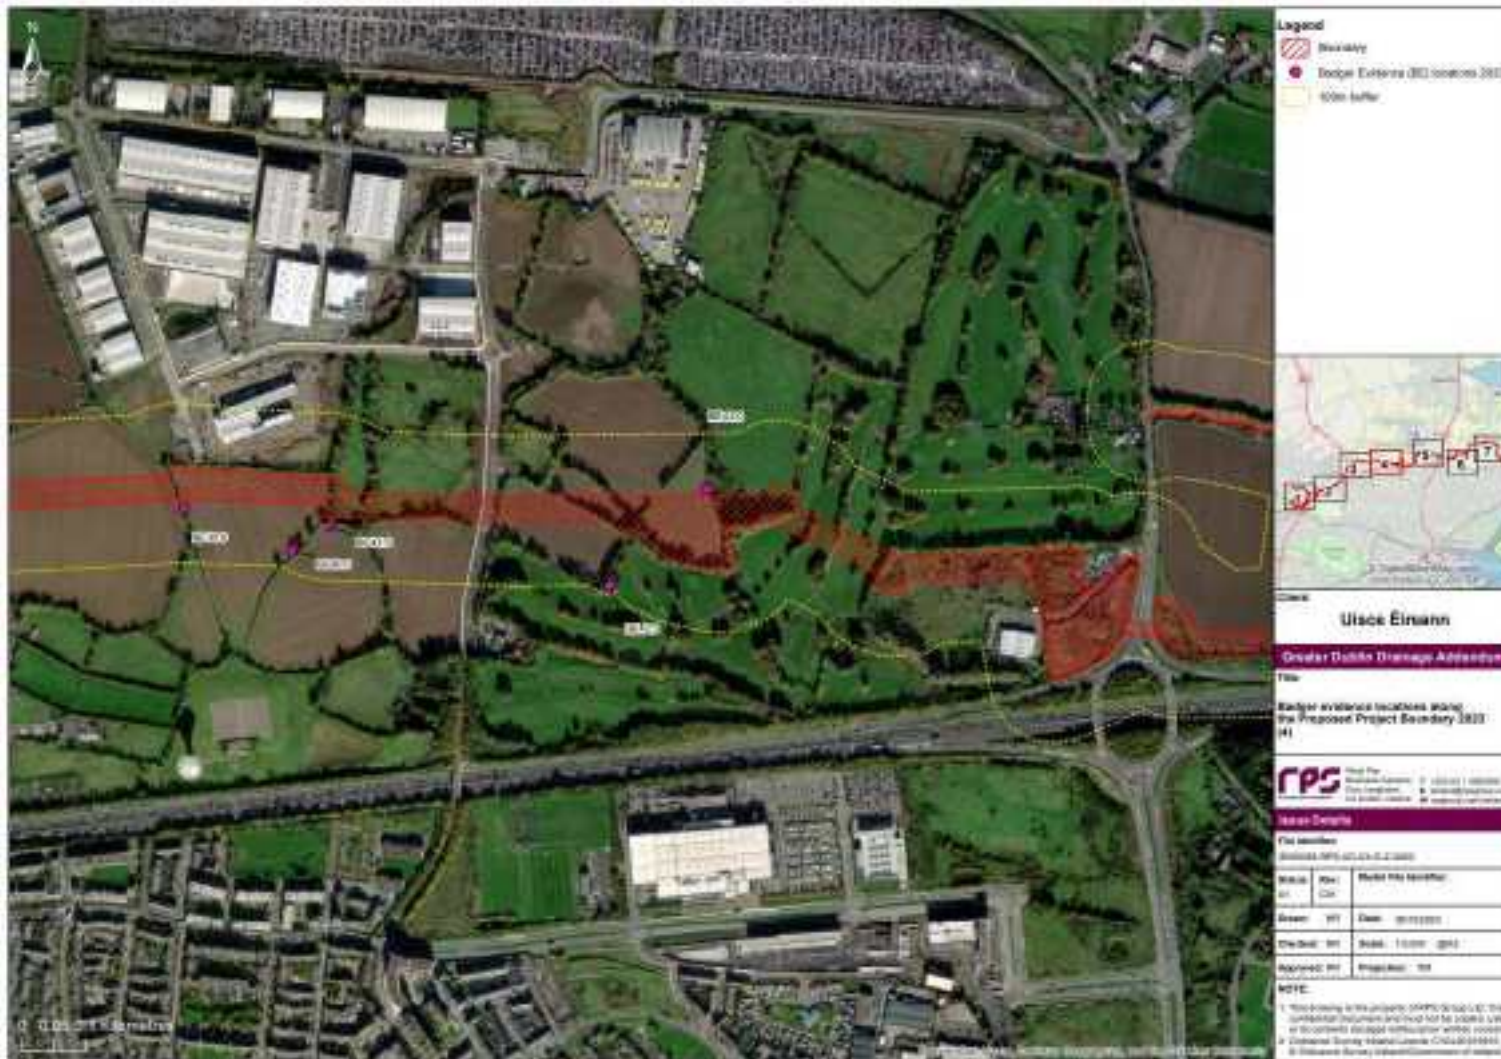
Figure C-5 Badger evidence locations along the Proposed Project Boundary 2023 (4)

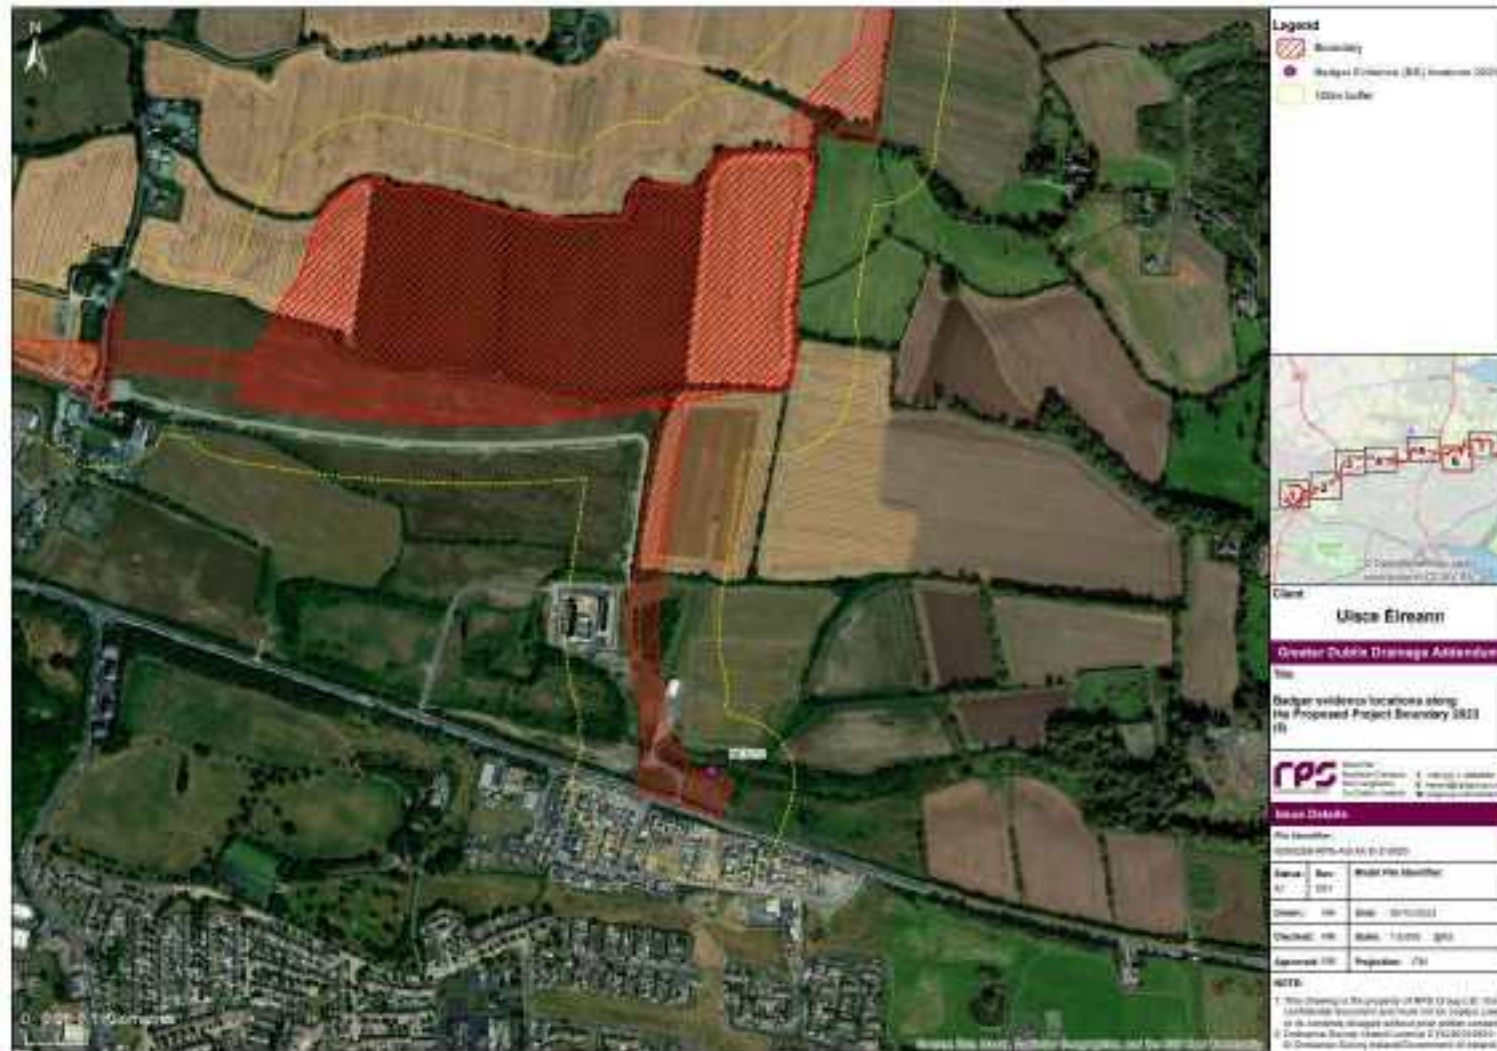
Figure C-7 Badger evidence locations along the Proposed Project Boundary 2023 (6)

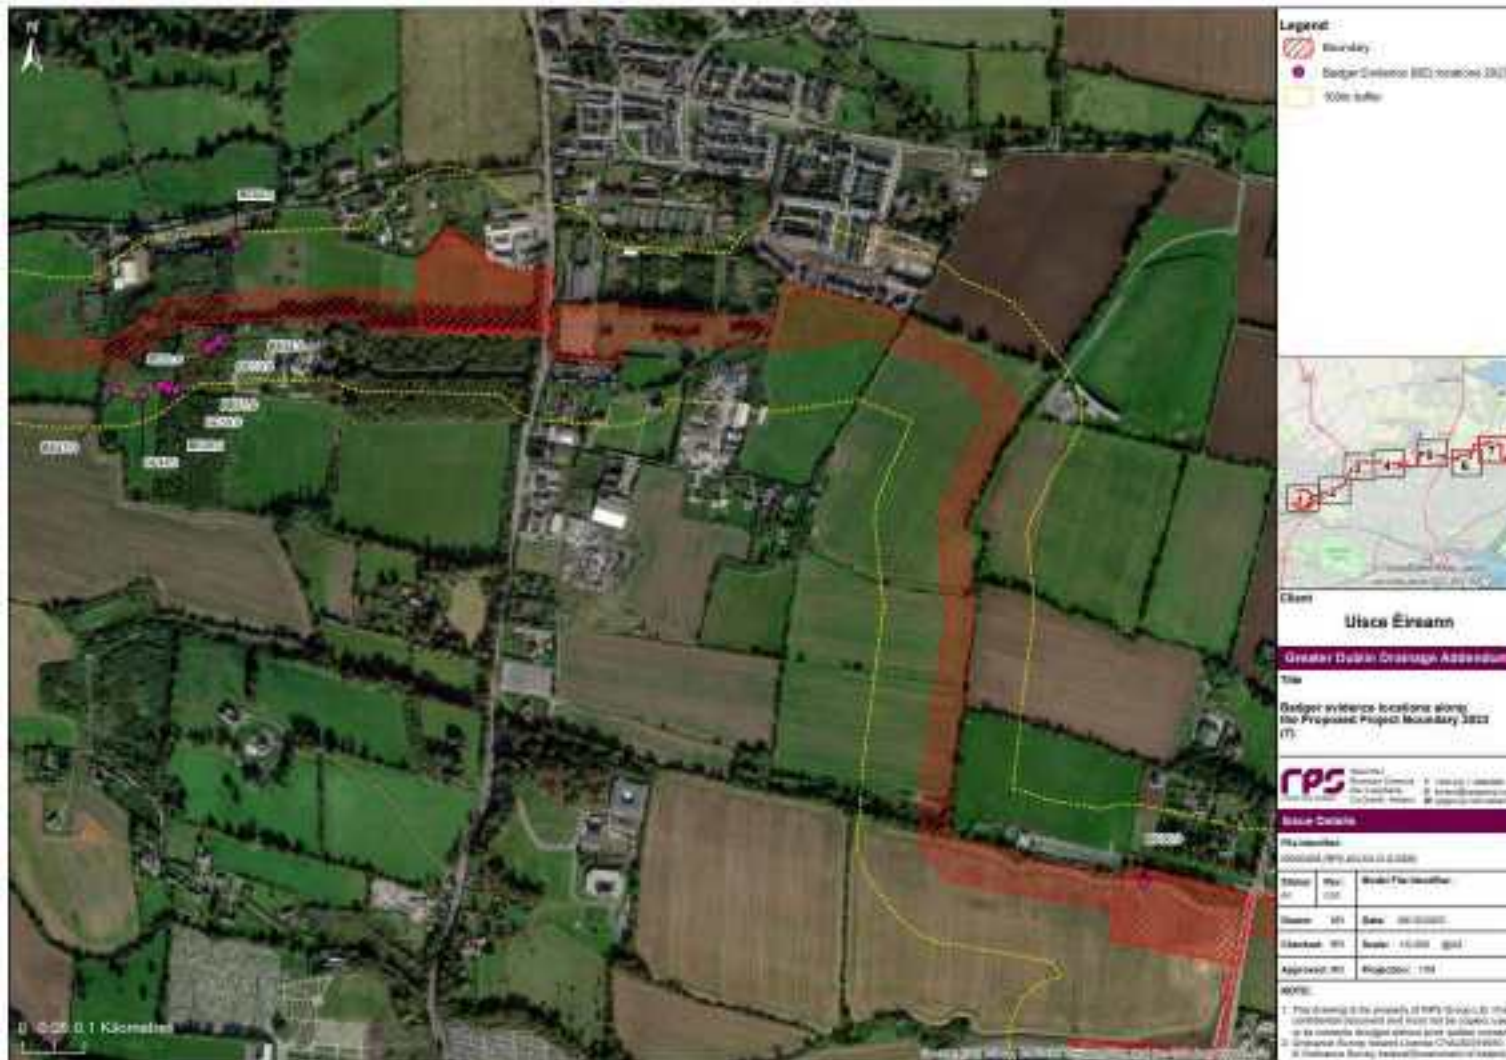
Figure C-8 Badger evidence locations along the Proposed Project Boundary 2023 (7)

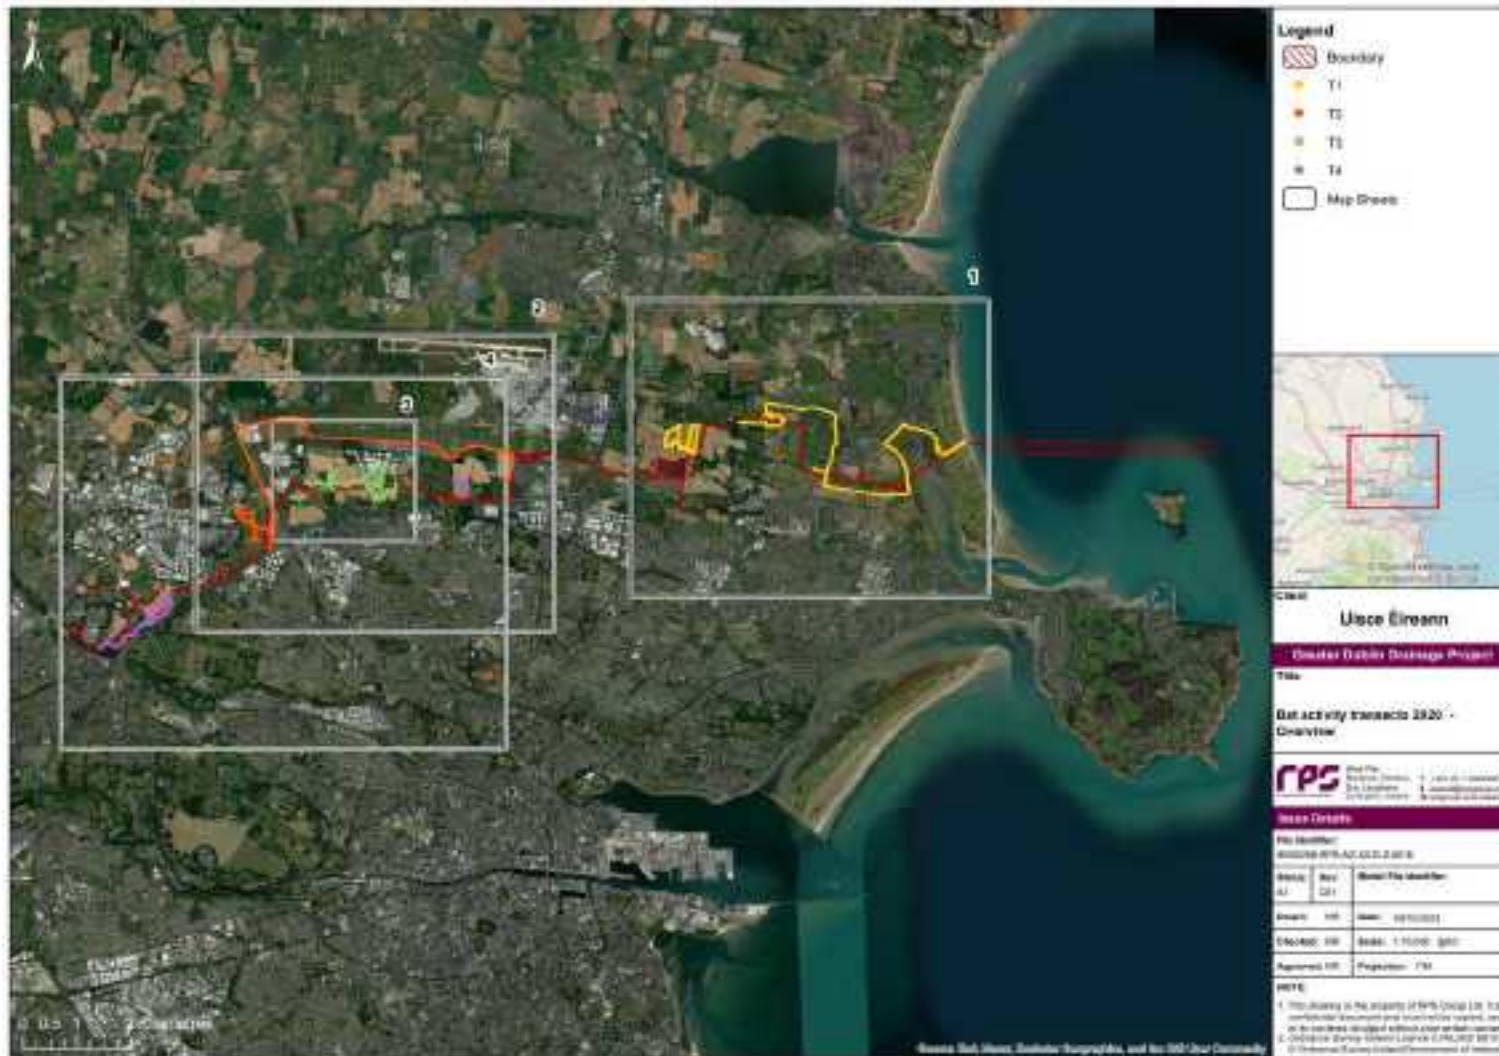
Figure E-1. Bat activity transects 2020 (overview^[JE1])

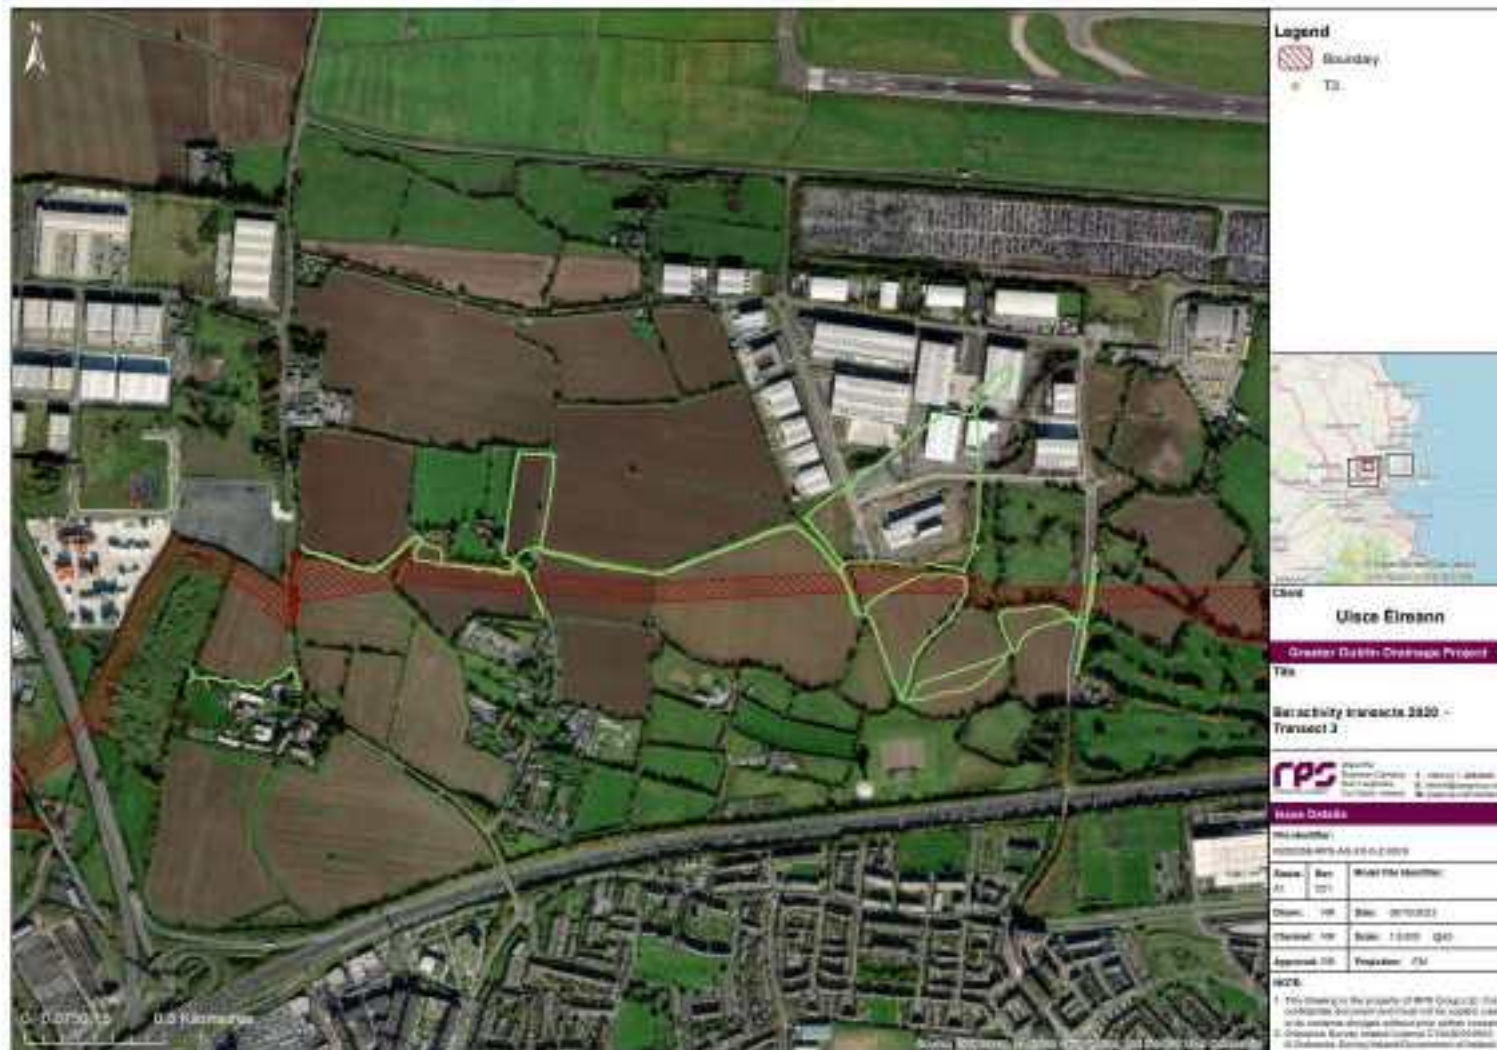
Figure E-3. Bat activity transects 2020 Transect 3

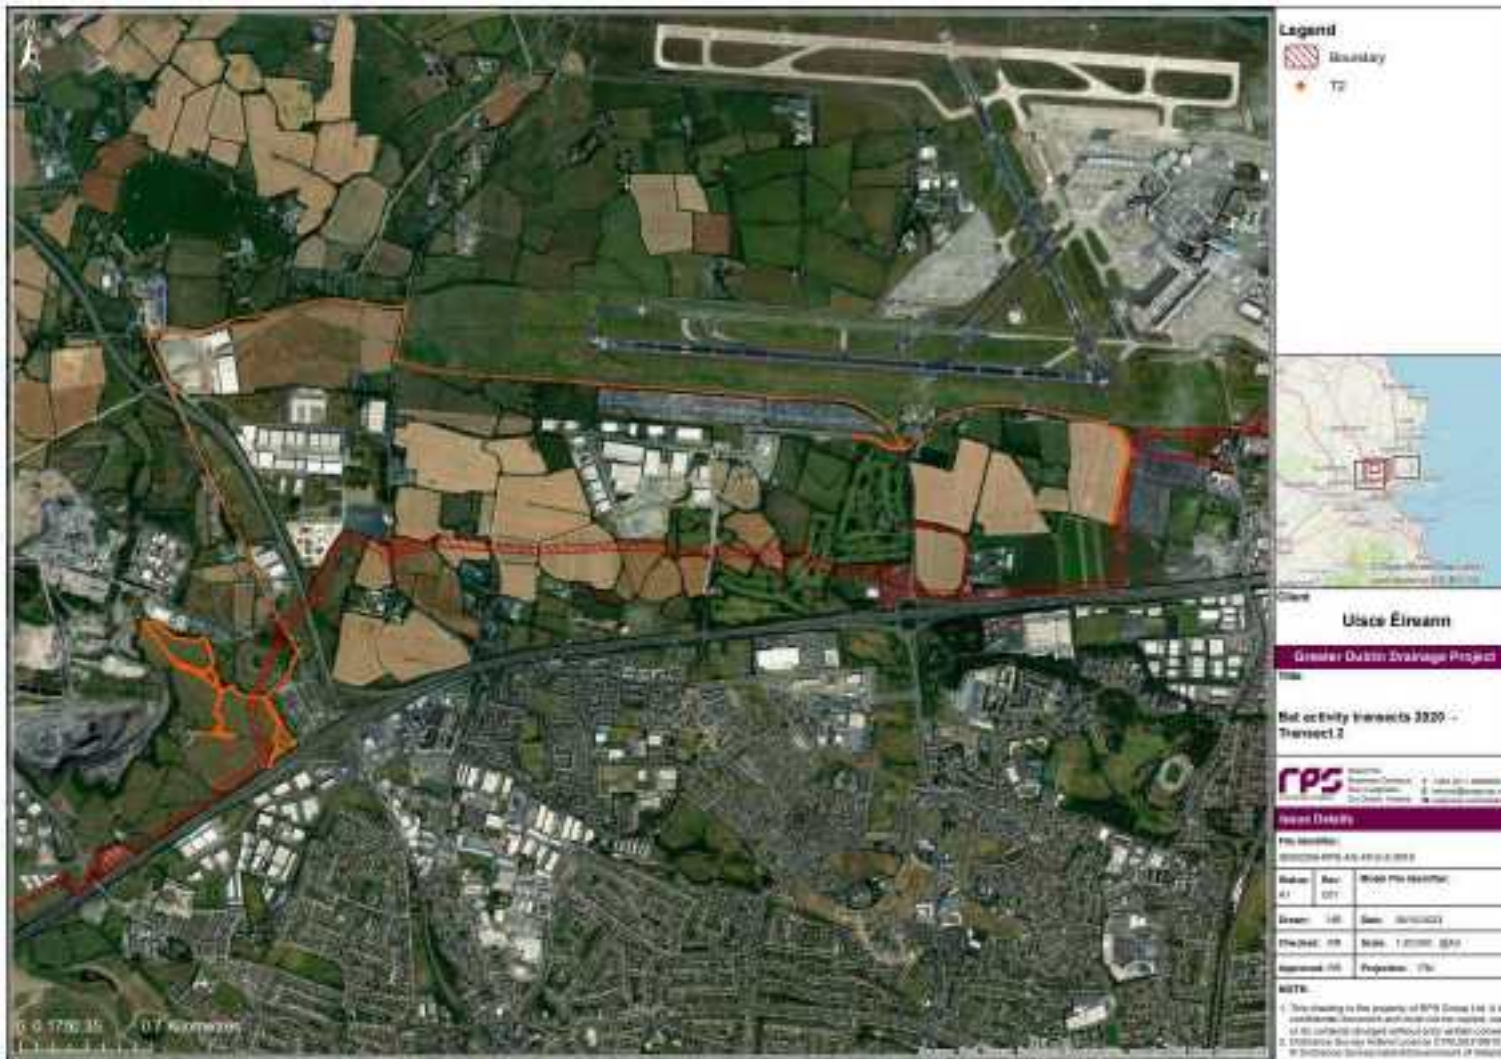
Figure E-4. Bat activity transects 2020 Transect 2

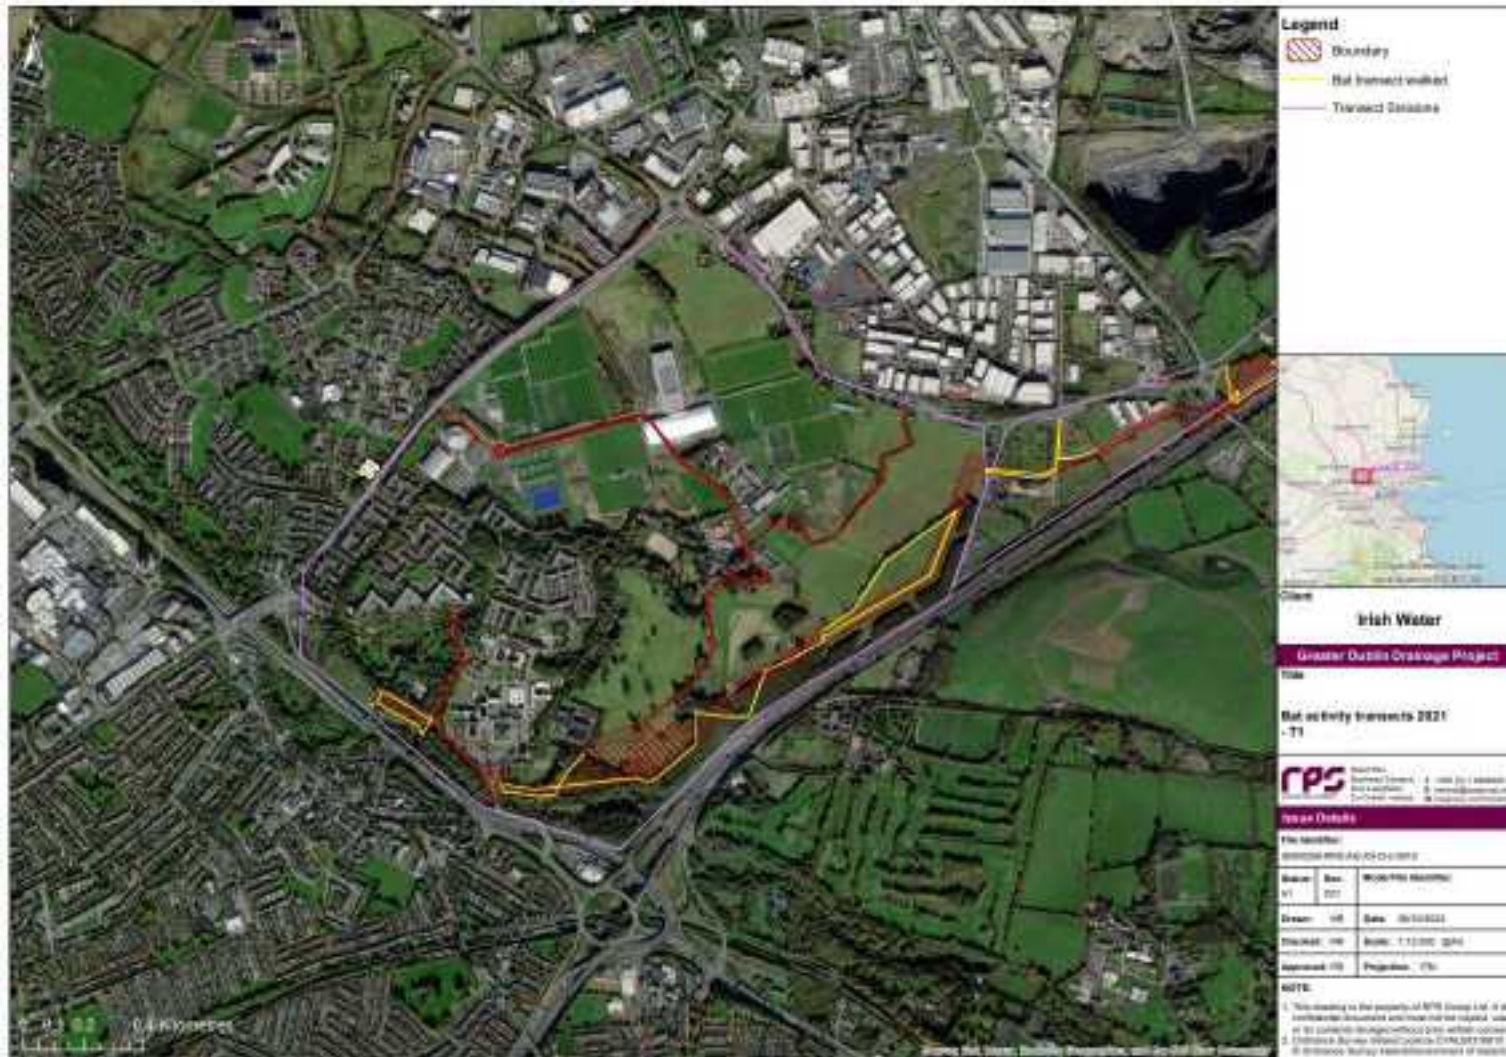
Figure F-2 Bat activity transects 2021 T1

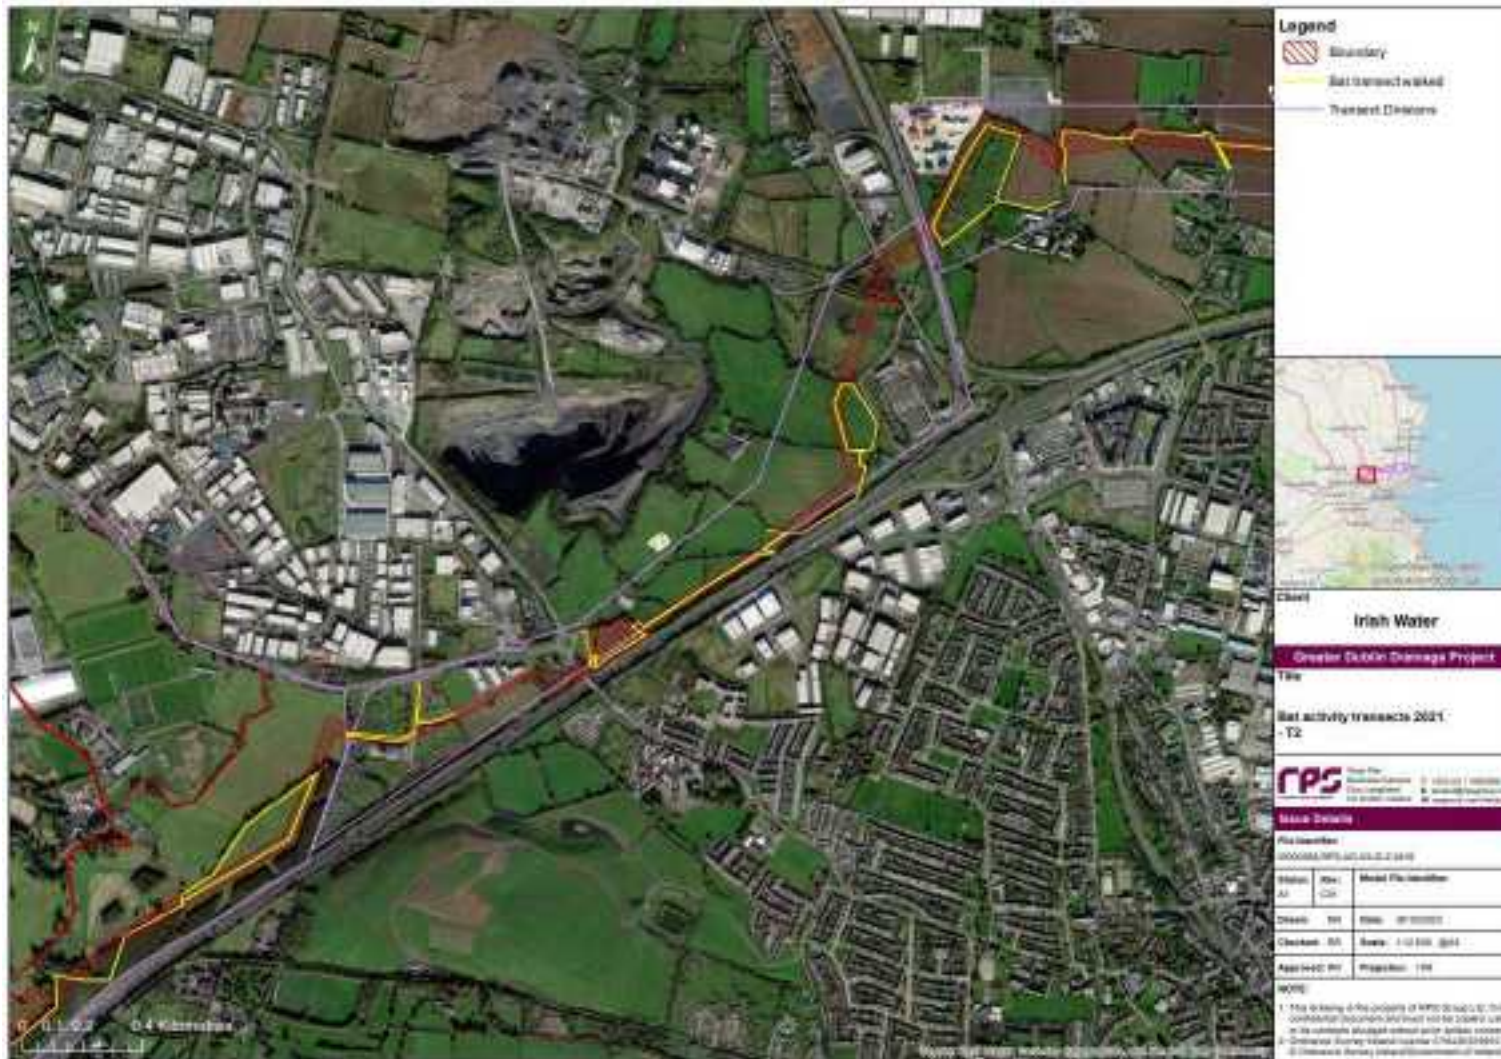
Figure F-3 Bat activity transects 2021 T2

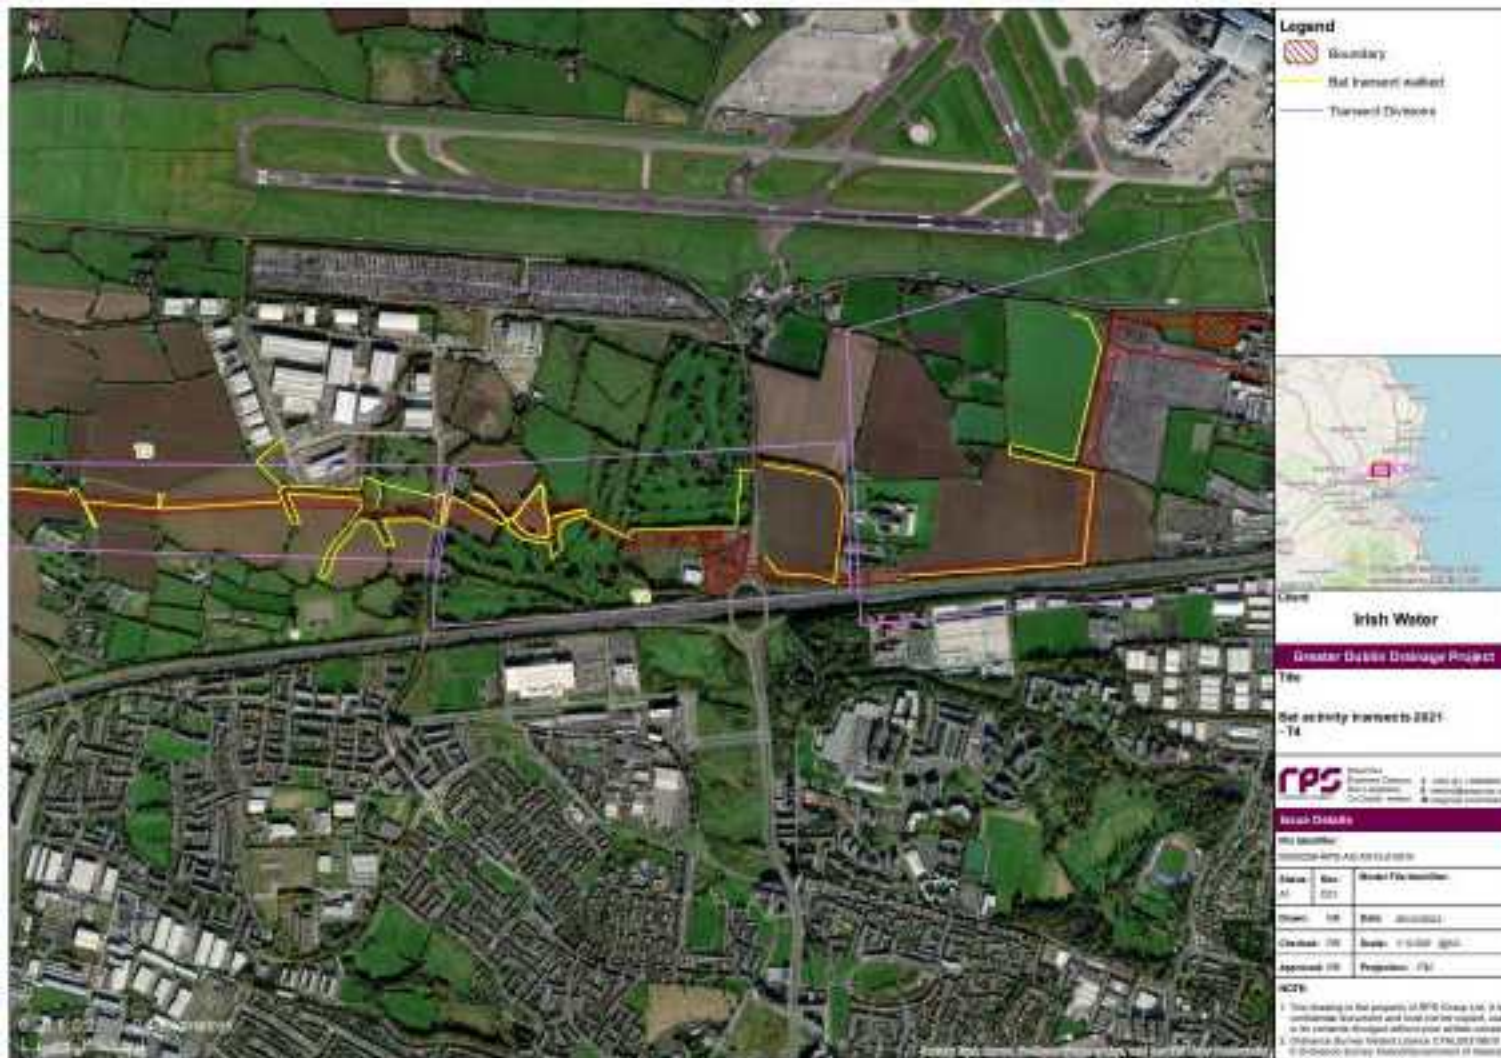
Figure F-5 Bat activity transects 2021 T4

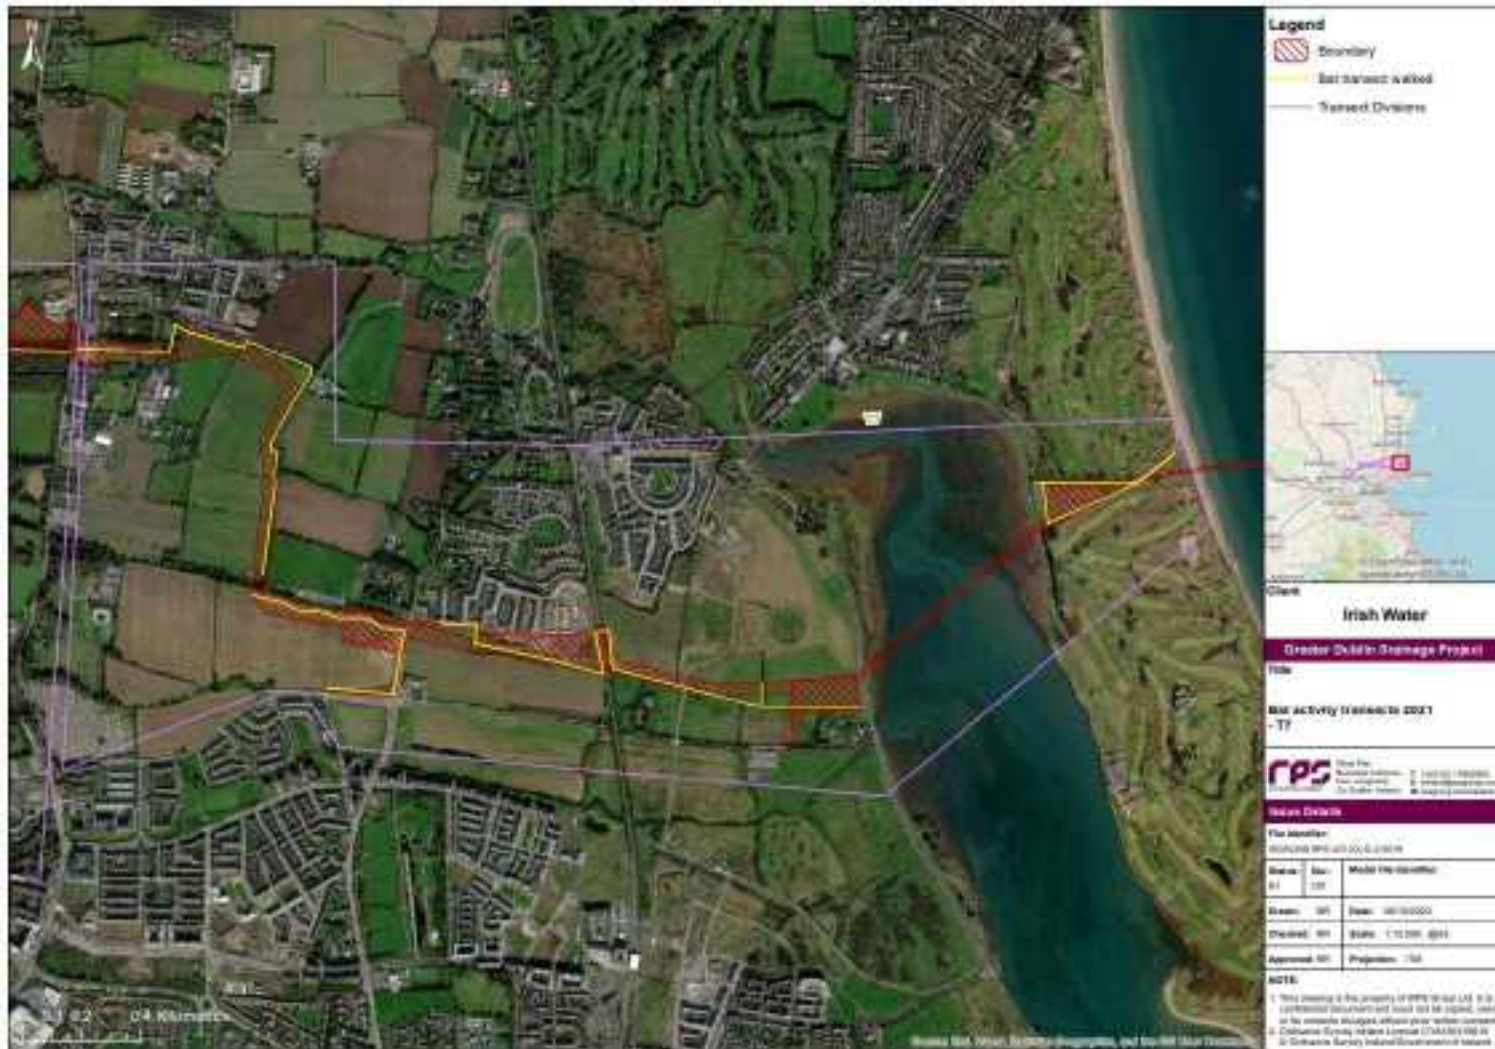
Figure F-8 Bat activity transects 2021 T7

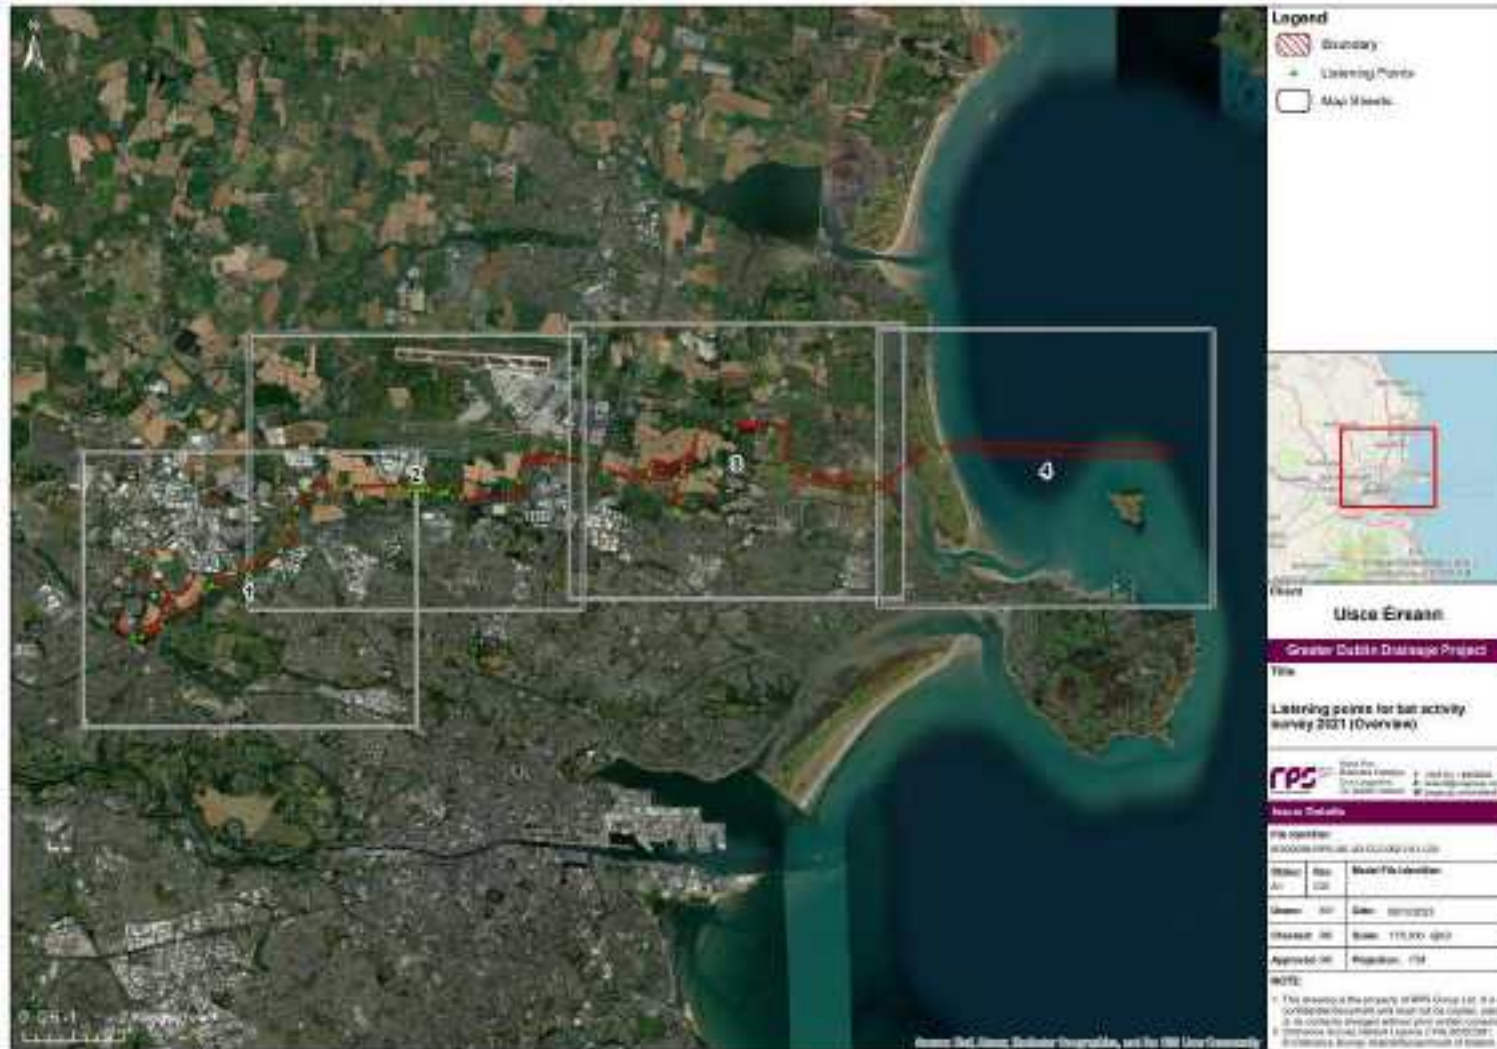
Figure G-1 Listening points for bat activity survey 2021 (Overview)

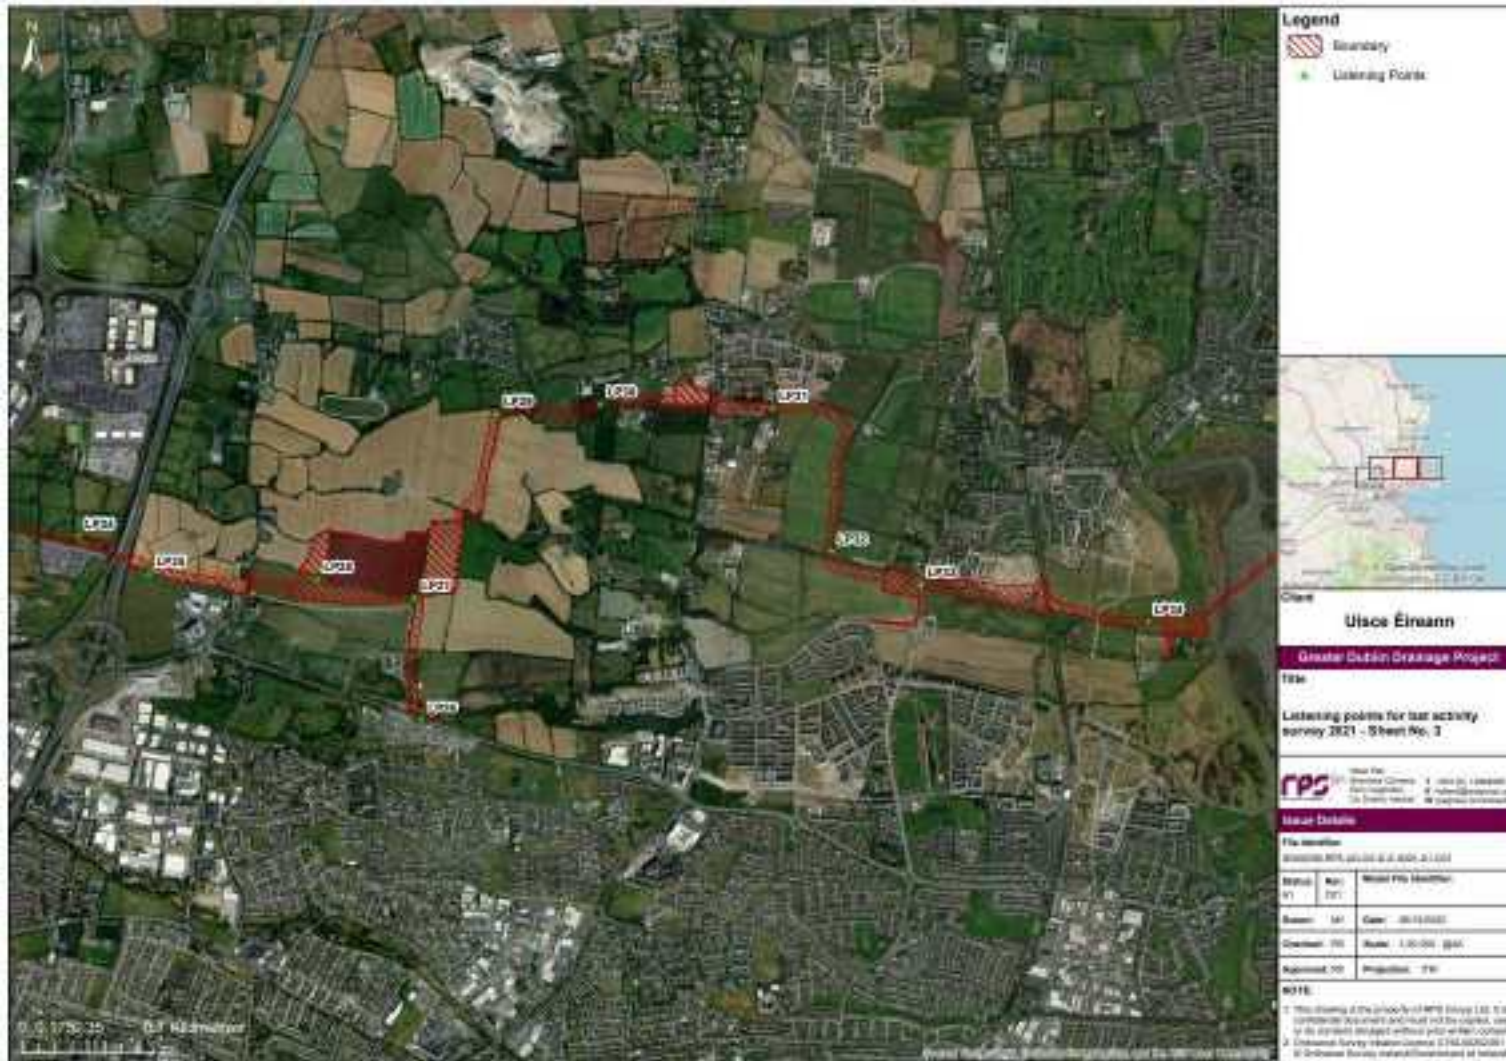
Figure G-4 Listening points for bat activity survey 2021 (3)

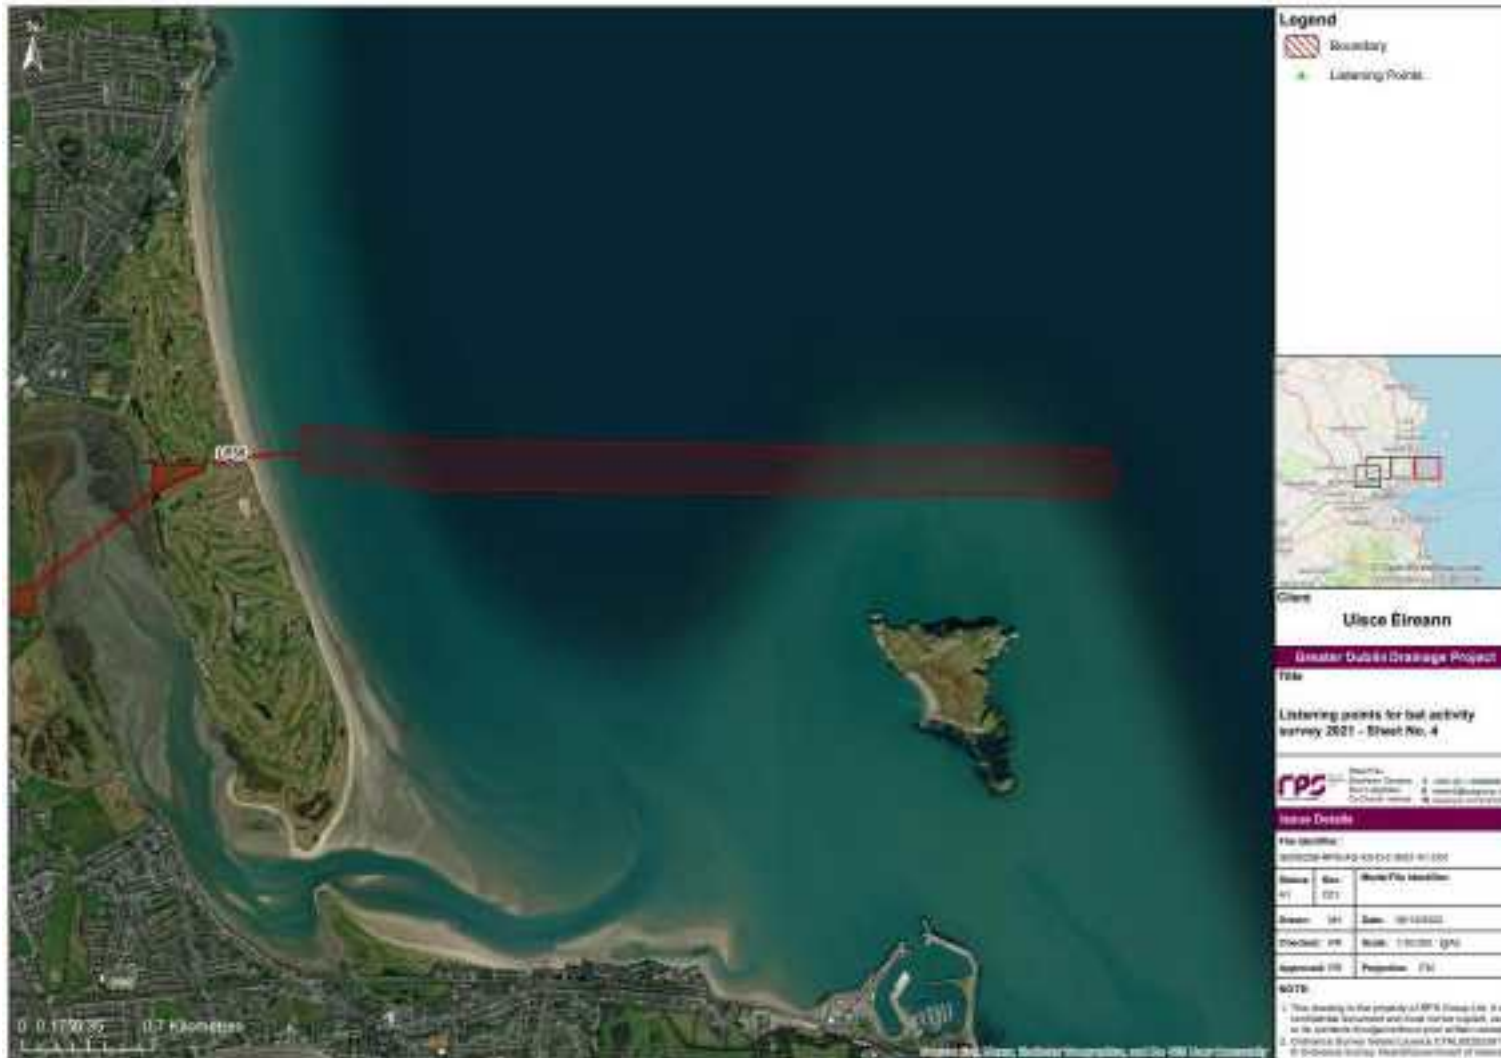
Figure G-5 Listening points for bat activity survey 2021 (4)
