GREATER DUBLIN DRAINAGE PROJECT

EIAR Addendum Chapter 11A (Biodiversity (Terrestrial and Freshwater Aquatic))
Appendix A11.1 Terrestrial Baseline Survey Report

IE000258
S4P01
October 2023

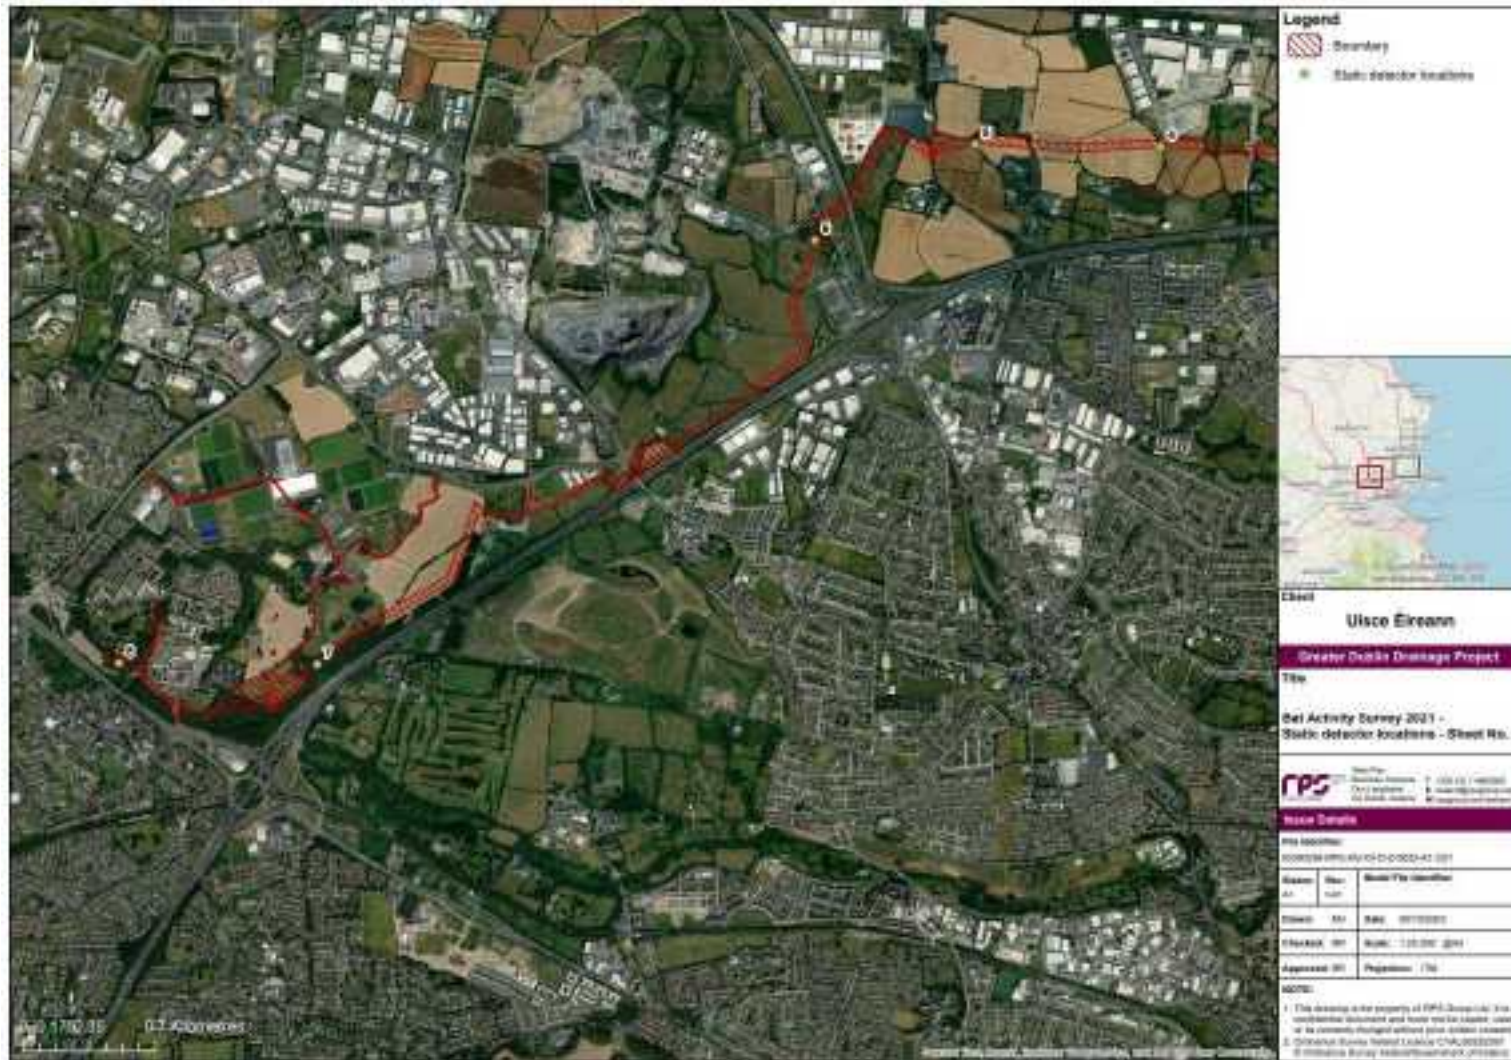
Figure H-2 Bat static detector locations 2021 (1)

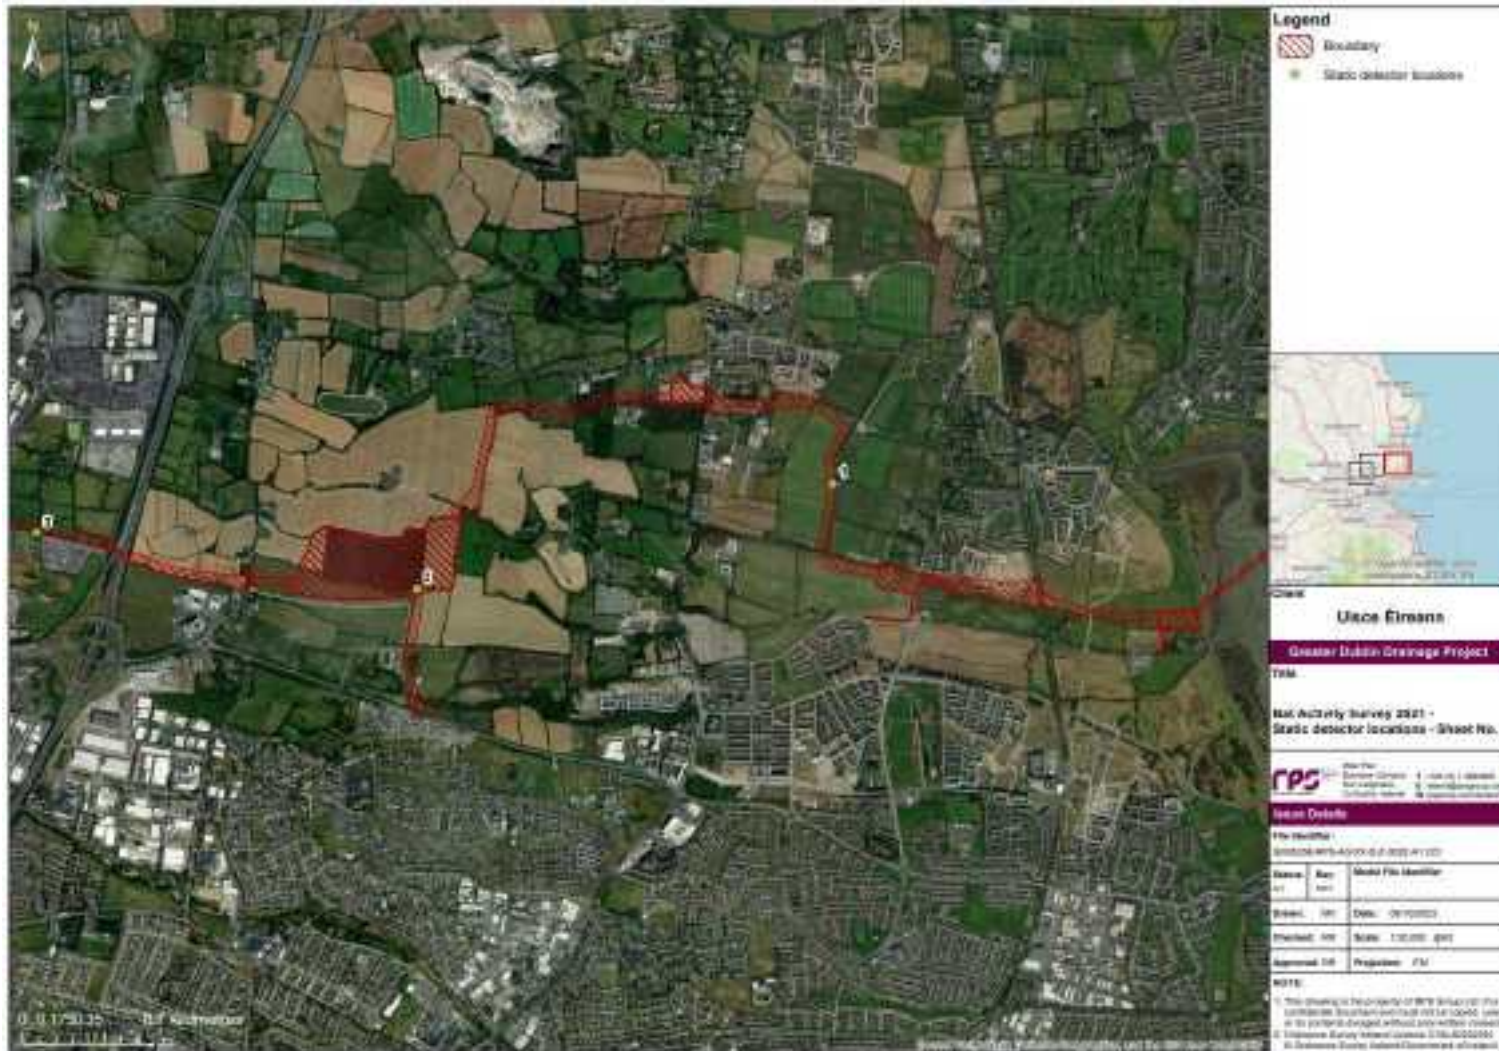
Figure H-4 Bat static detector locations 2021 (3)

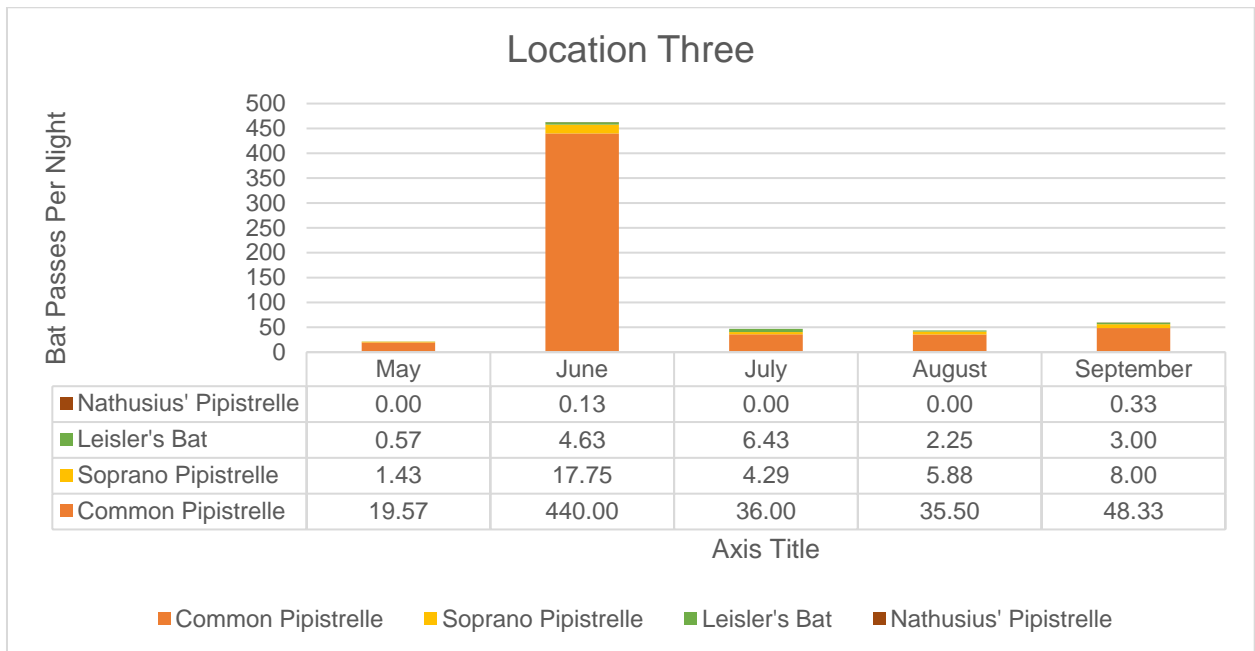
Figure I-3: Data Summary at Location Three

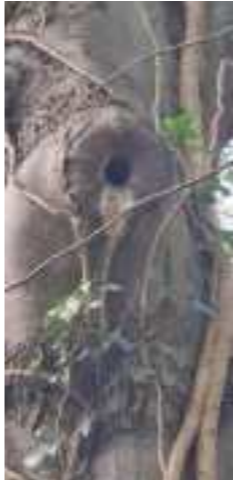
Knothole 6m high, external diameter 10cm, depth approx. 75cm, width 35cm, 80cm high, damp ground, dry inside, various sections, dome apex.				Prior to felling, an inspection must be carried out by a licenced ecologist to ensure that there are no roosting bats present.

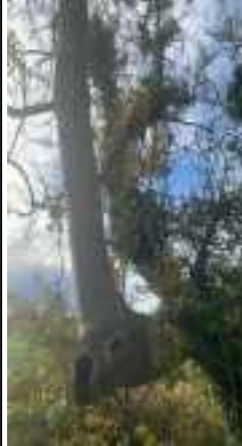
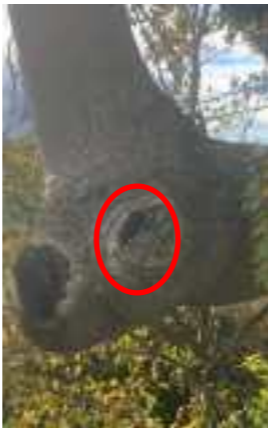
Ash tree with knothole	<u>Moderate</u>	<u>Moderate</u>

<p>Knothole approximately 1.3m high.</p> <p>Cavity depth 40cm x 5cm x 5cm, travels horizontally into the stem, dirty and damp inside.</p>						Prior to felling, an inspection must be carried out by a licenced ecologist to ensure that there are no roosting bats present.

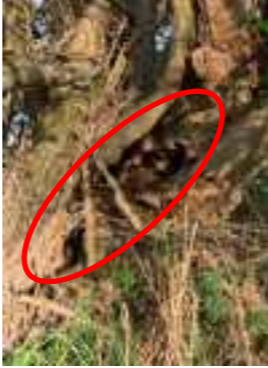
Ash with large cavity at the base	<u>Moderate</u>	<u>Low</u>

Limb has broken off near base of tree (approx. 30cm high), large limb tear out, limited places for bats to shelter inside, very exposed and at high risk to predation.						Prior to felling, an inspection must be carried out by a licenced ecologist to ensure that there are no roosting bats present.

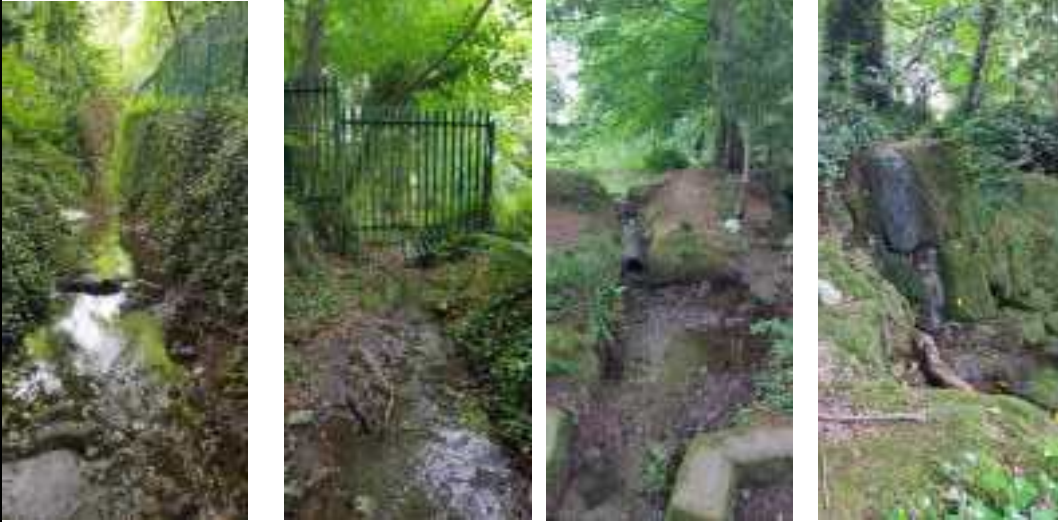
From left to right: the survey location looking upstream, the survey location looking downstream, the outfall of the pond downstream of the survey location, the waterfall downstream of the survey location.

Site 1b is located southeast of Connolly Hospital on the Abbotstown Stream. The stream is channelised, with high banks (ca. 1.6m). The stream flows into a man-made pool and over a waterfall before discharging into the mainstem of the River Tolka. The left bank comprises a concrete wall. The stream was approximately 1m wide and shallow (4cm deep) on the day of survey. Siltation at the site was moderate, and a high silt plume was noted when the bed was disturbed. Flow discharge was low with slow velocity. No colour and low turbidity were noted. The substrate was dominated by fine gravel. The river habitat comprised riffles (30%) and pools (70%). The substrate within the riffle habitat was embedded as a result of calcification. Shading was heavy, with ivy, sycamore, beech, hart's tongue fern and hogweed recorded adjacent to the stream.

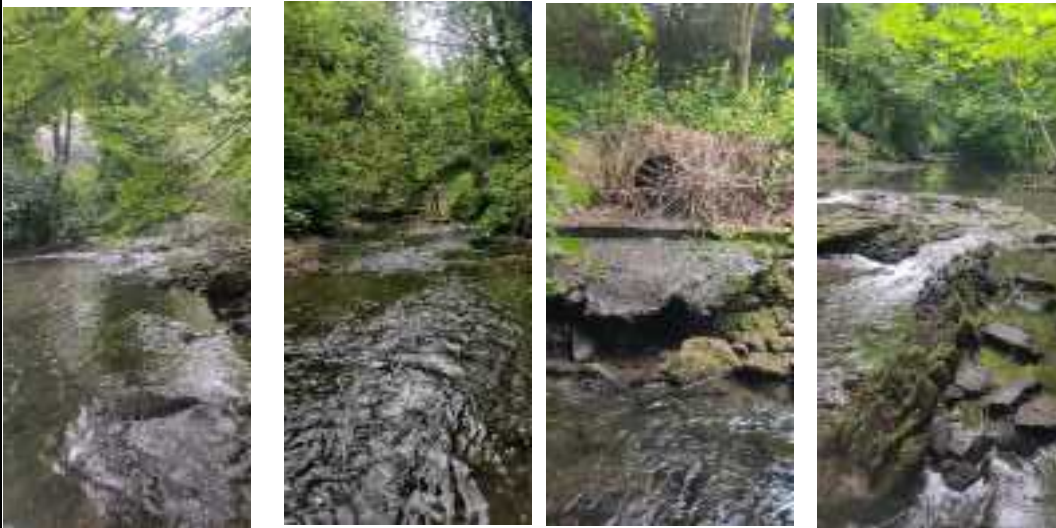
From left to right: the survey location looking upstream, the survey location looking downstream, the culvert pipe located on the right bank, the waterfall/bedrock outcrop upstream of the survey location.

Site 1c is located on the mainstem of the River Tolka, upstream of Abbotstown Bridge. The river is approximately 8 metres in width (wetted width between 2-8m), with water depth ranging between 10 and 45cm. The banks are approximately 2m in height. A culvert pipe (most likely a storm water outflow) is located on the right bank, with bank reinforcement (concrete and boulders) located around this point. Siltation at the site was moderate, and a high silt plume was noted when the bed was disturbed. Flow discharge was normal

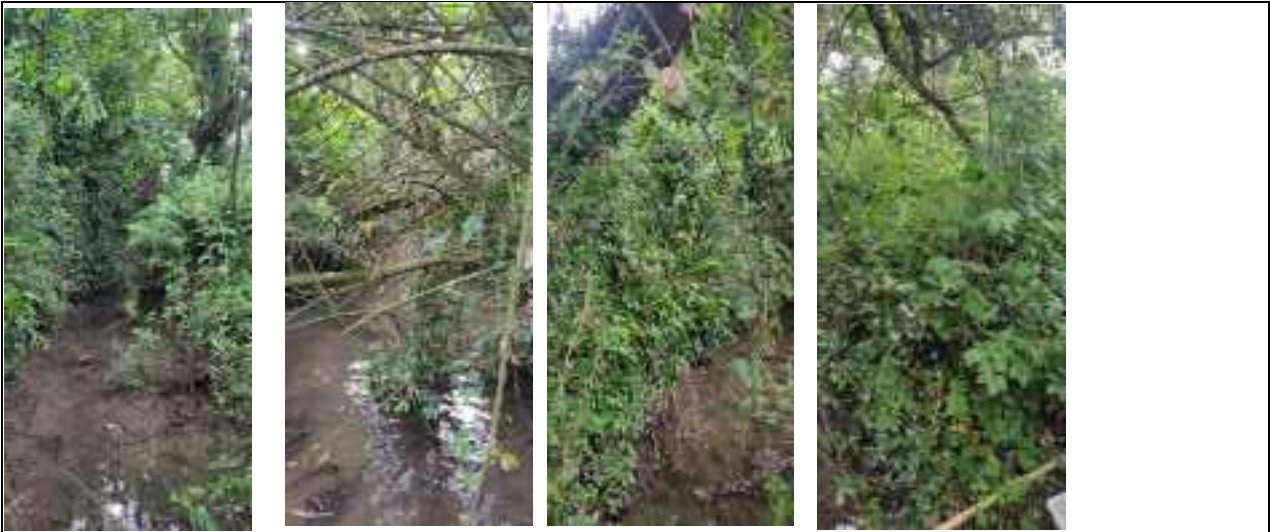
From left to right: the survey location looking upstream, the survey location looking downstream, the right bank, the left bank.

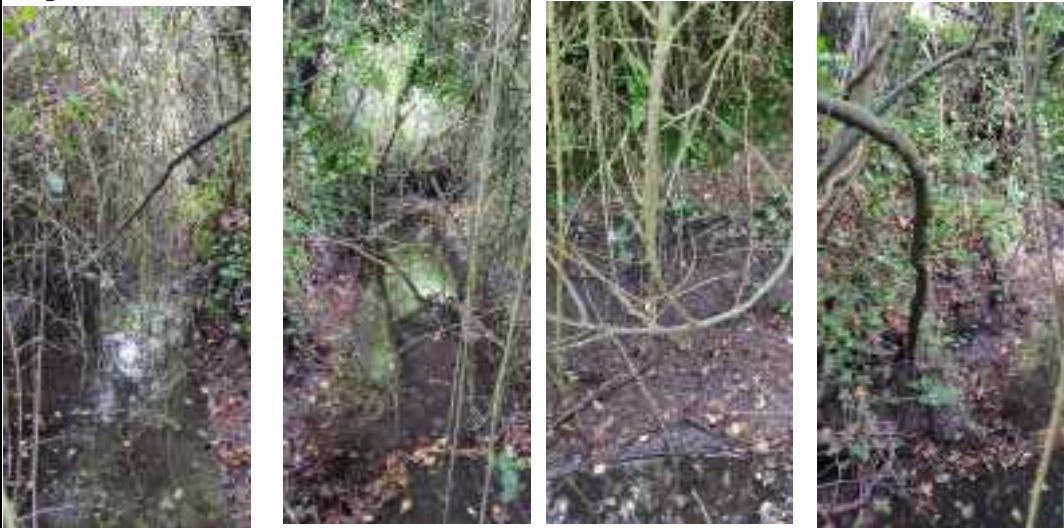
<p>From left to right: the survey location looking downstream, the survey location looking upstream, the right bank, the left bank.</p>

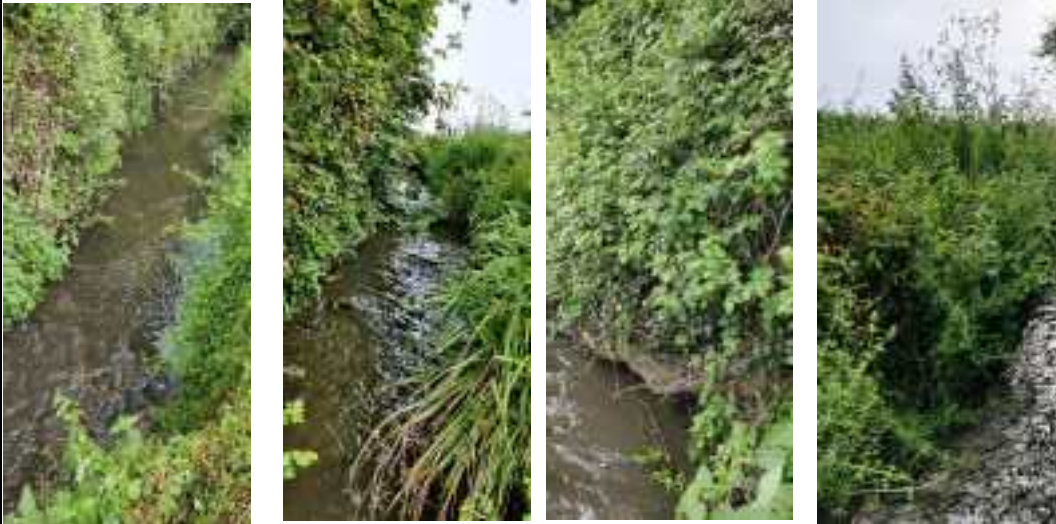
From left to right: representative image of the survey location, the survey location looking upstream, the right bank, the left bank.

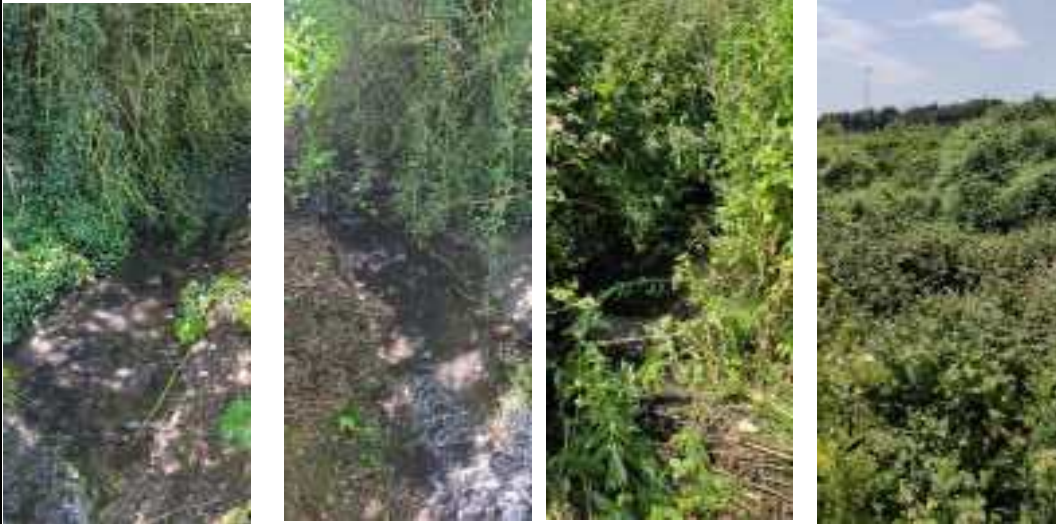
From left to right: the survey location looking upstream, the survey location looking downstream, the uppermost section of the surveyed reach, dense bramble growth within the stream valley.
